Systematic approach streamlines natgas pipeline pressure increase

Ales Brynych

CEPS a.s.

A sequence consisting of internal inspection, elimination of major defects, and subsequent pressure testing is the most efficient way to ensure the integrity and increase the operating pressure of aging high-pressure natural gas transmission pipelines.

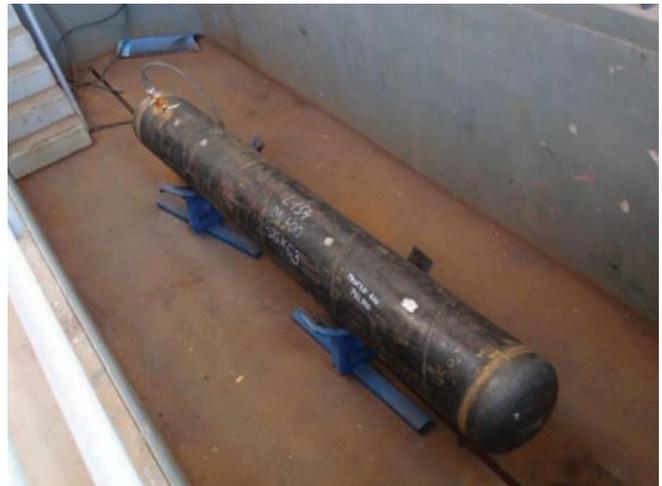
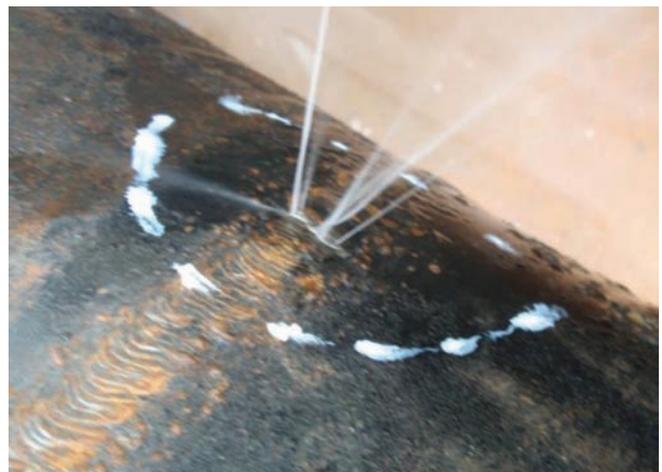
The pipe body vessel was destroyed on the circumferential weld at 16,632 MPa (Figs. 1 and 2).

Pressurization to 16,632 MPa destroyed the test vessel at its circumferential weld (Fig. 2).

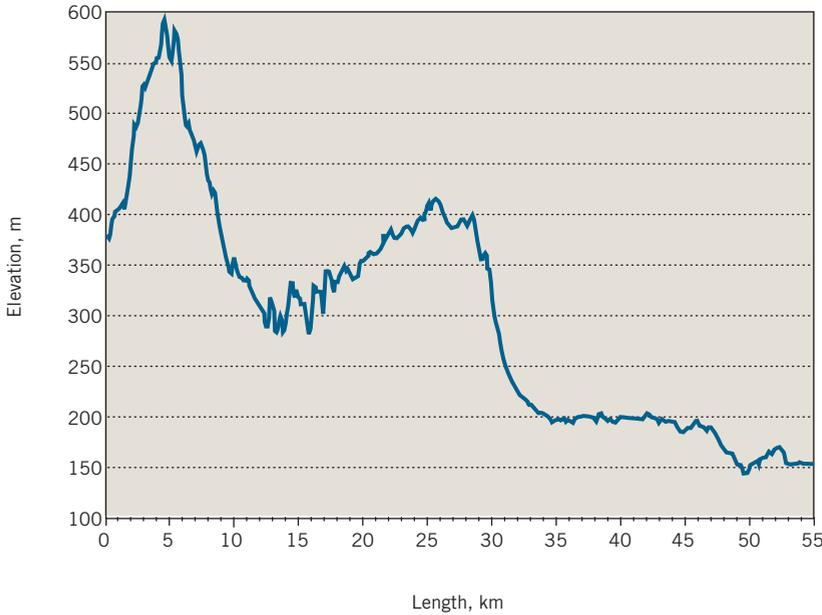
FIG. 3

Division of the gas pipeline into working sections proved extremely difficult, the territory through which the pipeline travels more resembling the Bohemian–Moravian highlands or foothills of the Giant Mountains than the Polish plain. Fig. 3 shows the pipeline’s longitudinal profile, elevation ranging from 100 to 600 m over its 55 km.

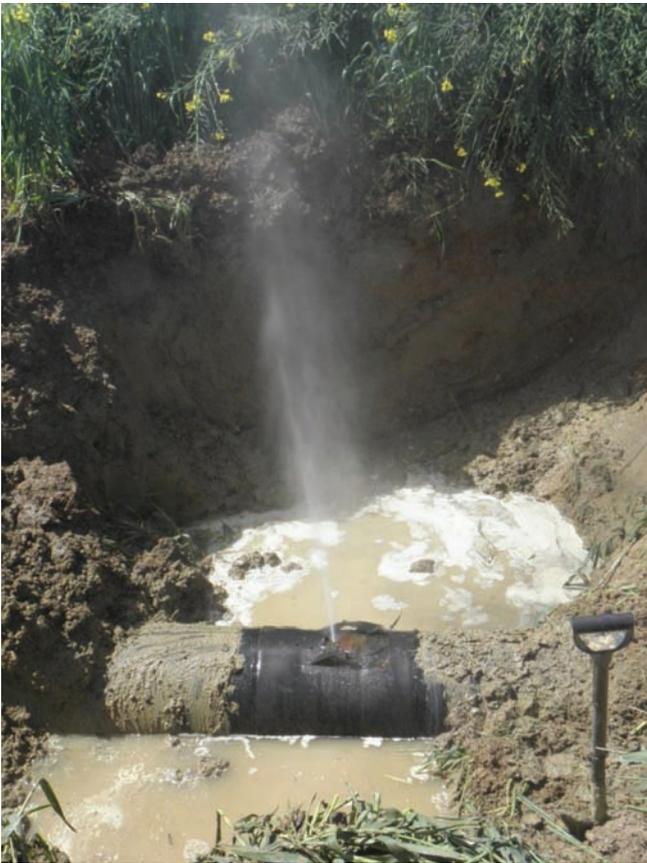
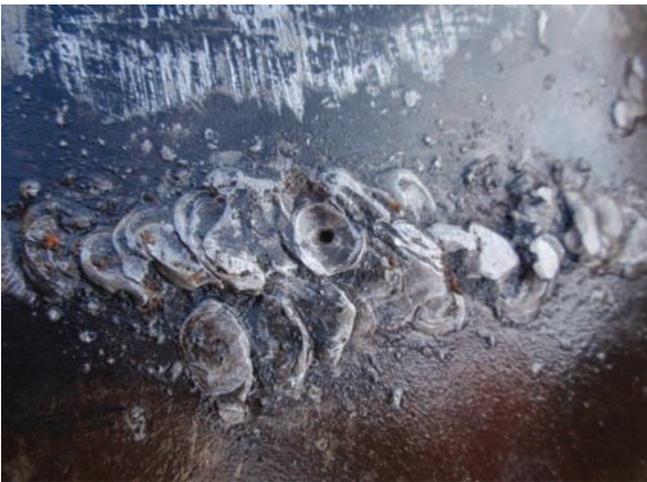
A flawed circumferential weld in the field burst under testing. A close-up shows both the lack of workmanship in the initial weld and the defect which failed (Figs. 4 and 5).

Integrity testing twice resulted in destruction of the pipe. The first was on a segment of pipeline built in 1997. During a time delay after reaching maximum pressure in the first pressure cycle, a significant drop in pressure occurred. Results of the first cycle of integrity testing and theoretical calculations estimated a 411-l./hr leak. This relatively large water leak was favorably situated, the defect on the upper part of the pipeline in relatively dry terrain was found during a walk of the line. A thorough moistening of the terrain in the area of the defect and repeated pressurization and subsequent spontaneous depressurization of the gas pipeline allowed the exact location of the leak to be found (Fig. 4).

The site revealed a sloppy circumferential weld (Fig. 5). The welder did not spare any material in completing a weld that was perforated at its root. It is surprising that this weld passed initial inspection (B2, according to Czech standard TPG 702 04) carried out during construction of the pipeline in 1997. By comparison, construction of B2 pipeline DN 1000 from Lanžhot towards Mount St. Catherine, Czech Republic, built in the same period, subjected all circumferential welds to radiography tests, among other inspections.

Technicians immediately re-examined ILLI inspection results, but no anomalies were found in the MFL tool's record, confirming CEPS's experience in internal inspection of more than 400 km of gas and product pipeline that intelligent MFL pigs are unable to detect pipeline defects of this type and scope.

The pipeline is secure after properly performed integrity tests. Once operational, however, the operator should inspect any referred sections with increased scrutiny, frequent patrols along the pipeline with a gas leak detector, and detection of faults in isolation by the Pearson method.
