# Comprehensive Approach to the Decommissioning of Oil Pipelines

««««««««««««««««  
Aleš Brynych »»»»»  
Aleš Crha »»»»»

CEPS a. s.  
CEPS a. s.

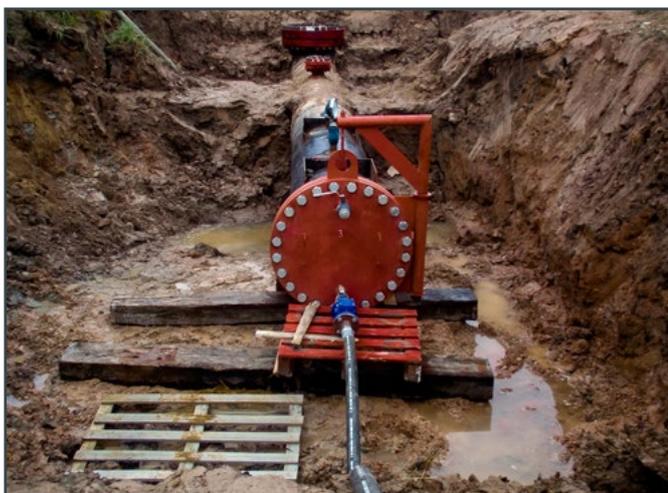
Figure 2: CEPS temporary launcher trap

For emptying the pipelines were divided into a total of 11 sections. Existing launching and receiving pig traps were used when possible and to the remaining section ends a CEPS temporary launchers/receivers were installed (Figure 2).

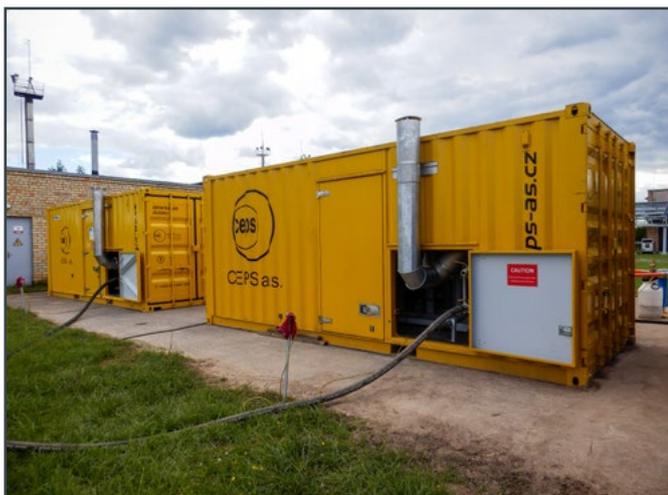
Figure 3: CEPS mobile nitrogen generators

Two pigs were inserted into each launcher and a water batch was created by pumping water in between them. These water batches were then propelled through pipeline sections by inert nitrogen mixture containing more than 90% of nitrogen. Two CEPS mobile nitrogen generators produced sufficient volume of nitrogen to move the water batches and the whole content of the crude oil through the pipeline sections (Figure 3).

In the second phase after the chemical cleaning the pipeline was purged by the nitrogen mixture containing 95% of nitrogen. After that the nitrogen pressure in the whole pipeline system was increased to 3 bar. To do that CEPS used its mobile nitrogen units again (Figure 9).

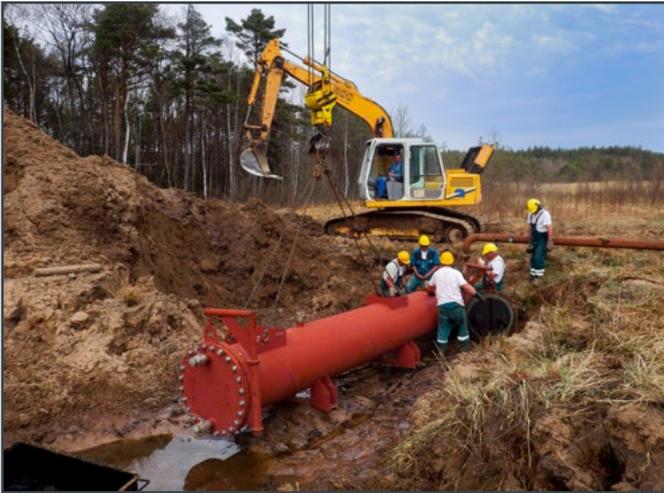
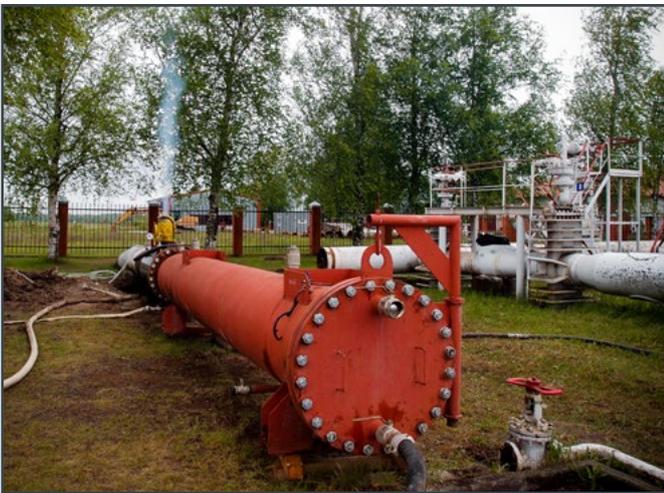
Figure 4 and 5: Temporary traps for chemical cleaning

For the chemical cleaning special temporary CEPS launchers and receivers were fastened or welded to both ends of each cleaning section (Figure 4 and 5).

Technicians inserted several cleaning pigs to each launcher and pumped a predetermined amount of CEPS PETROSOL 1 agent to create cleaning batches with different fixed agent concentrations. The final batch of each cleaning train was water. These cleaning trains were propelled through cleaned pipeline sections with compressed air.

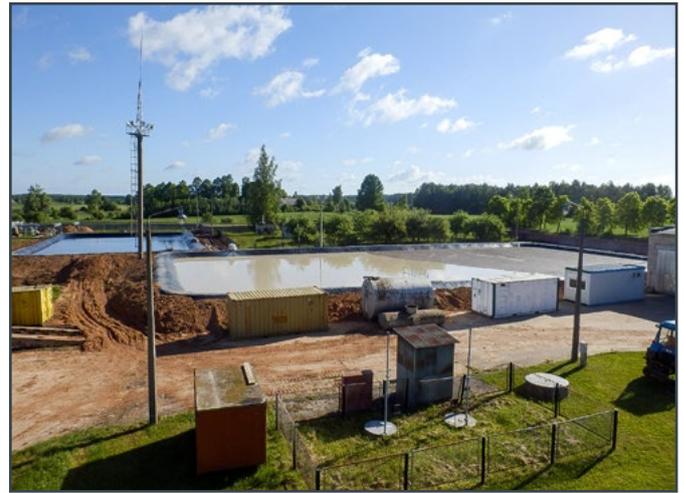
Figure 7: Temporary reservoirs

- CEPS disposed 3 000 m<sup>3</sup> to Mazeikiai refinery water treatment plant,
- CEPS disposed another 10 000 m<sup>3</sup> pumping them into temporary reservoirs in Džukste and Skrudaliena pumping stations (Figure 7) using a biodegradation cleaning method. The hydrocarbons concentration in water after the cleaning reached 0.6 mg/l and therefore it was possible to pump this water into the river.

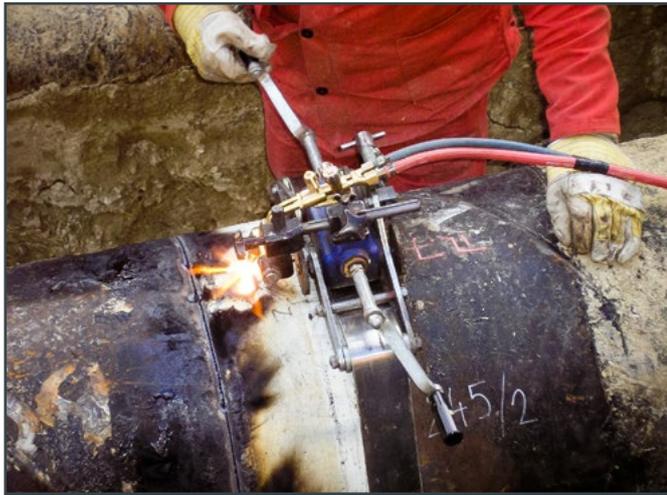
Figure 8: Flame cutting at permanently explosion safe conditions

After completion of the chemical cleaning the pig traps were flame cut from the pipeline, the interconnections of the pipeline sections were made and free ends were blinded by cups. It was possible to make all these welding and cutting jobs safely at permanently explosion safe conditions (Figure 8) that considerably improved the efficiency of the work.

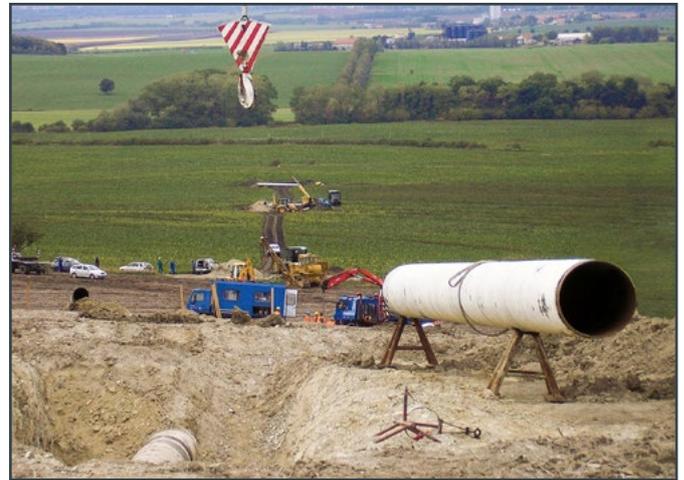
Figure 10: Spread of some jobsites

One of many examples of this approach is the repair of 21" Druzhba crude oil pipeline in Czech Republic, where CEPS replaced 32 pieces ten-meter long defective pipes spread on about 10 km of the pipeline in 4 days. During first 2 days the pipeline was emptied and chemically cleaned and during next 2 days the defective pipes were cut out and replaced. In total 16 welding crews were working simultaneously on the pipeline, each crew replaced 2 pipes. The spread of some jobsites is shown in Figure 10.
