> by: Aleš Brynych, CEPS a. s. & Alexandrs Jelinskis, LatRosTrans Ltd

A new approach to the results of internal inspection

Possible solutions when existing pipeline exceeds the expected lifetime

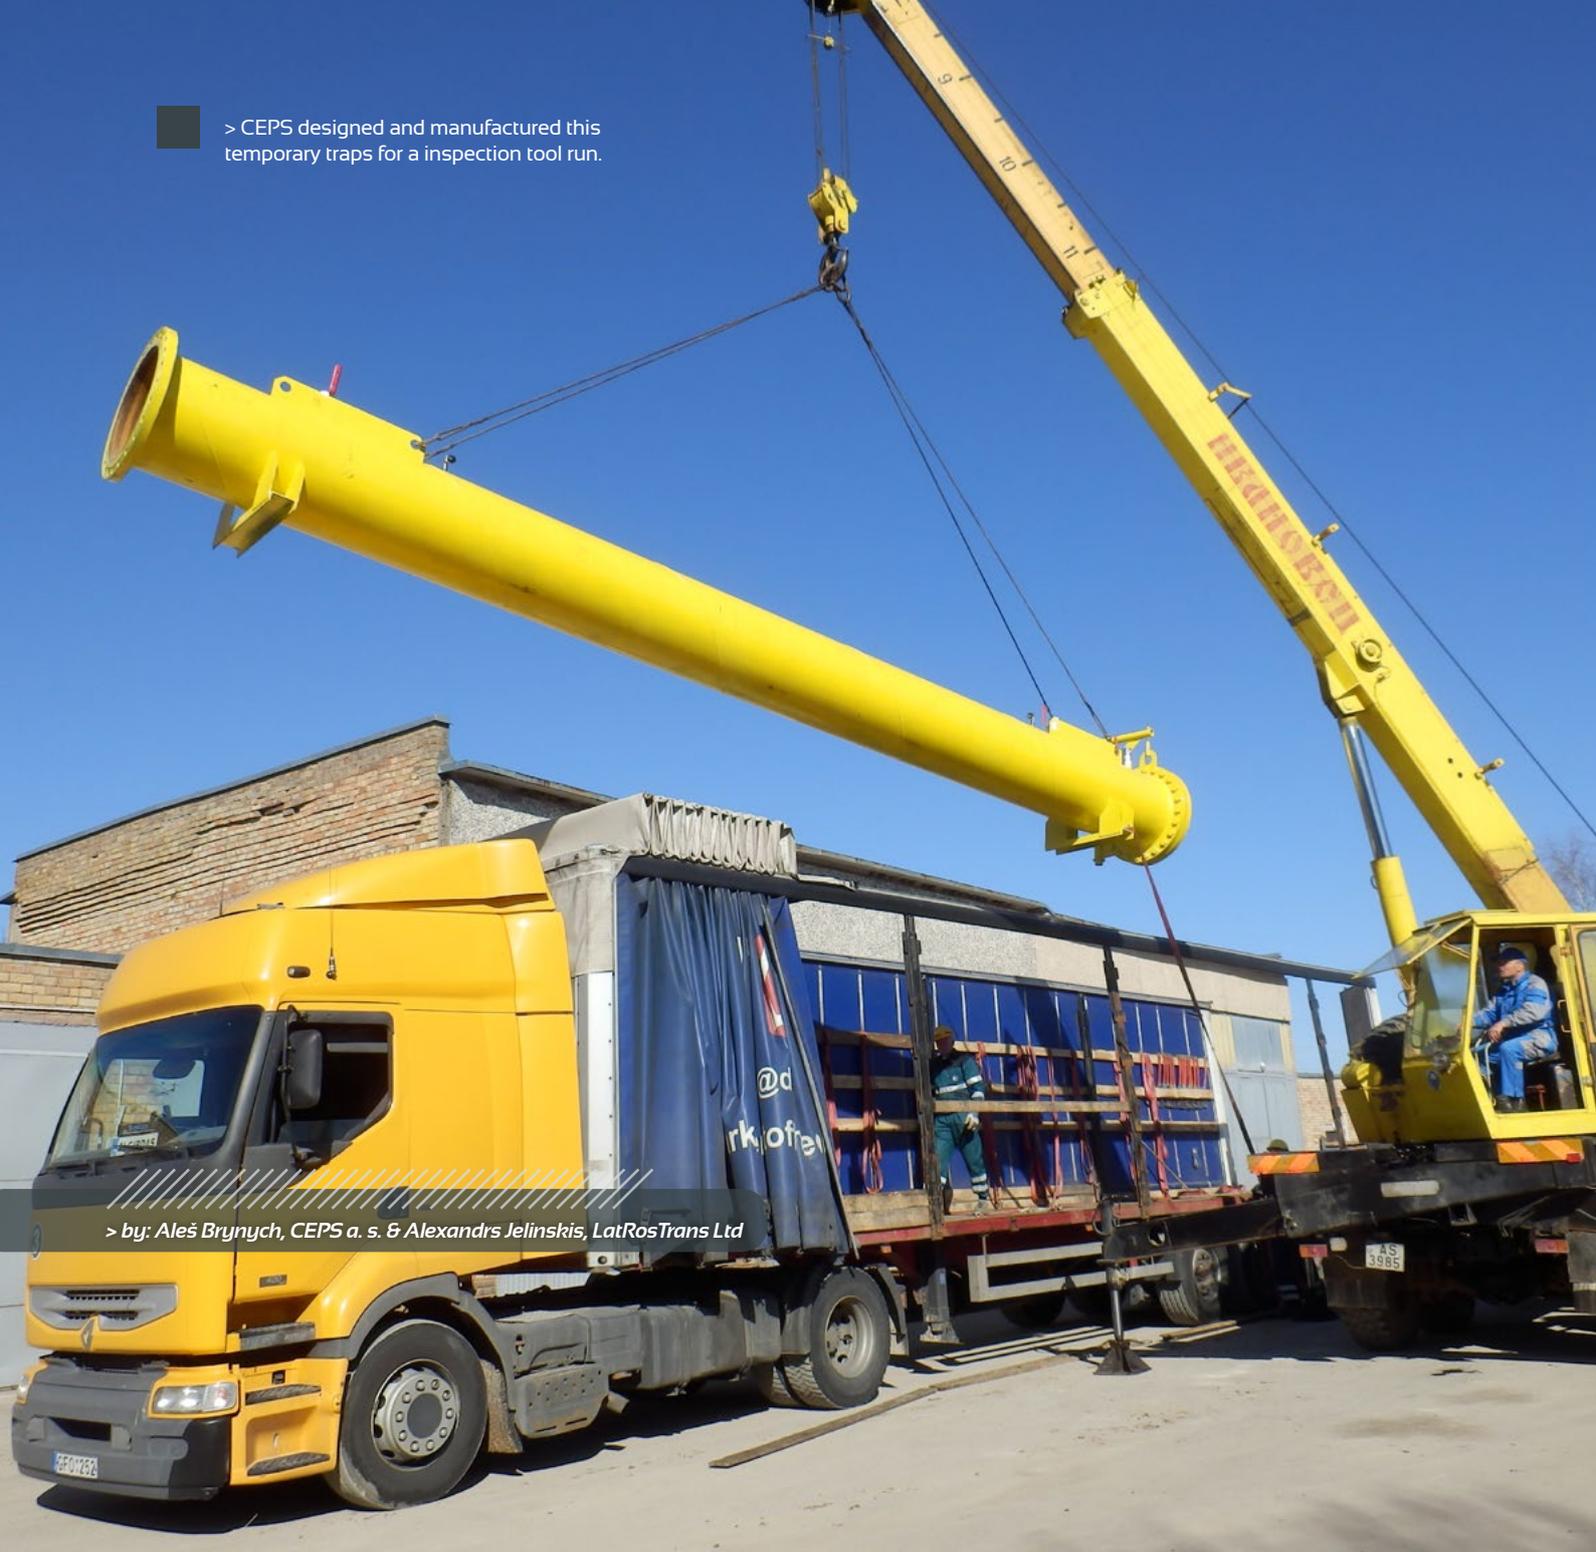
> CEPS designed and manufactured this temporary traps for a inspection tool run.

In 2000 the MFL and UT internal inspection of the pipeline was carried out. After subsequent shut down of the pipeline it was not expected further development of fatigue defects (particularly the creation and growth of cracks caused by changing pressures in the oil pipeline. Based on this fact the pipeline operator decided to carry out the internal inspection using TFI tool before the integrity test. The section was not equipped with launching and receiving traps and therefore CEPS designed a manufactured the temporary traps for the inspection tool run (see Figures 3 and 4).

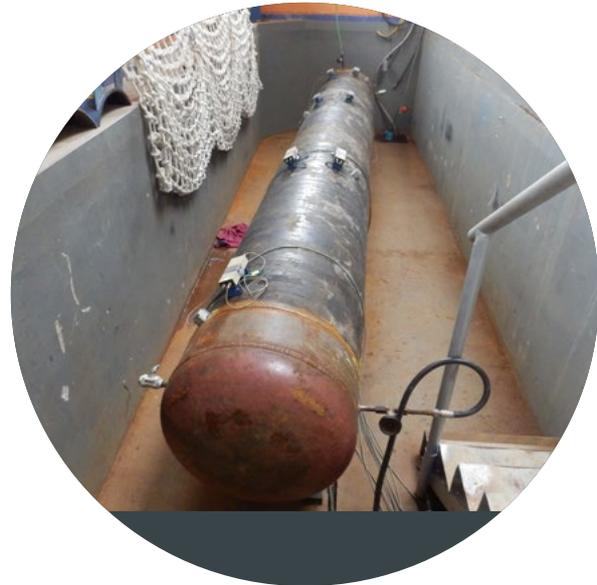
Figure 1: Pipe test vessel

Integrity test of pipeline material was modelled on a test vessel manufactured from a pipe taken from the pipeline section (see Figure 1). The parameters of the test were specified based on the results of material properties testing.

During the integrity test the following measurements and monitoring were carried out and recorded continuously:

- Measuring of test pressure dependence on added water volume,
- Monitoring of the crack growth using the acoustic emission,
- Measuring of local deformations and microdefects.

Completed material tests proved the high quality of steel material of the oil pipeline section. After more than forty-year period of operation there were no signs of degradation of pipe material. Acoustic emission showed that a reduction of internal stresses in the pipe material and a stabilization of defects occurred during the test.

Based on the results of all the tests, the maximum allowed test pressure and the maximum allowed value of plastic circumferential deformation for on-site integrity test of the pipeline were determined.

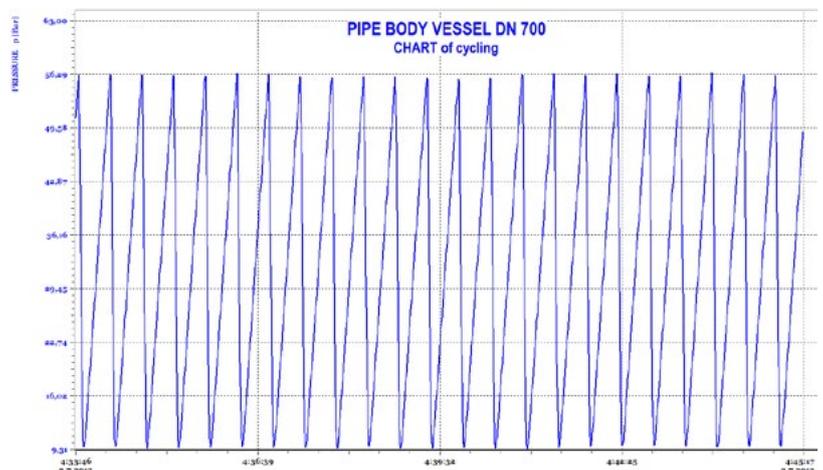
Figure 2: Cyclic fatigue test - part of p-t chart

The test of resistance to cyclic fatigue and the crack growth caused by the fatigue mechanism was performed by high cycle loading (see Figure 2) on the same test vessel as the integrity test. The fatigue test was performed under these conditions:

- Pressure amplitudes were from 5 bar to MAOP,
- 15 000 of cycles simulated 30 years of the future pipeline life.

During the fatigue test, no development of dangerous defects was detected by acoustic emission. Simulation of the long-term operation by cyclic pressure loading verified the considerable life-time extension which was achieved by the integrity test.

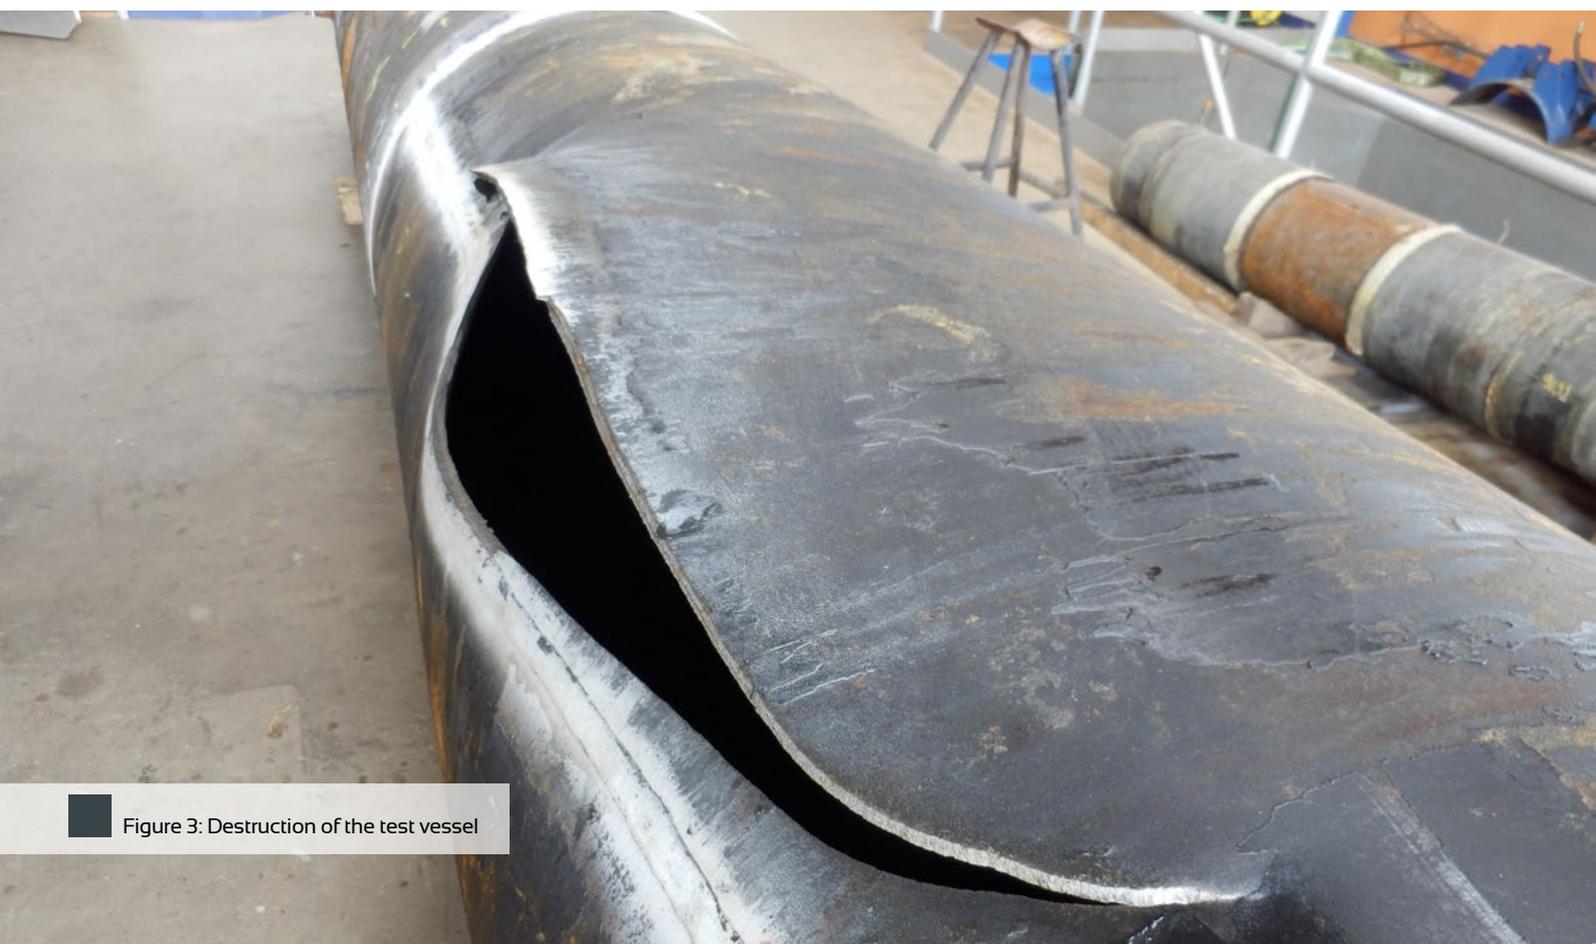
Figure 3: Destruction of the test vessel

The test vessel was pressured up to the ultimate strength limit R_m of the pipe material. When pressure achieved the value of in advance calculated pressure of ultimate strength, the destruction of the longitudinal weld occurred (see Figures 3).

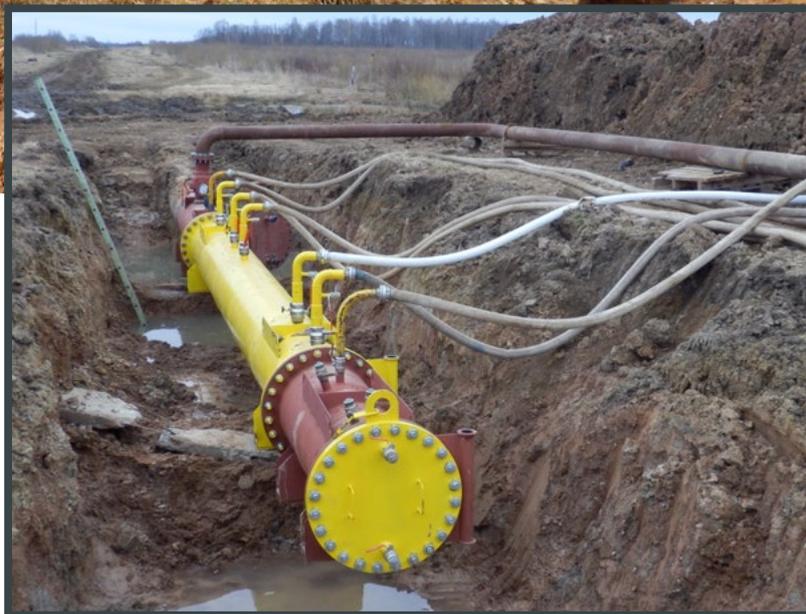
Figure 5: Launching trap with the water supply pipeline and hoses

To ensure the supply of this huge amount of water CEPS built 4 water lines to connect mobile pumps with the end of the inspected pipeline section (see Figure 5). After removing of the inspection tool from the receiving trap, the check of measured data was done. This confirmed that the TFI tool was already at its first run propelled through the pipeline section at the required velocity (see Figure 6 on the next page) and the measured data were good for their further processing.

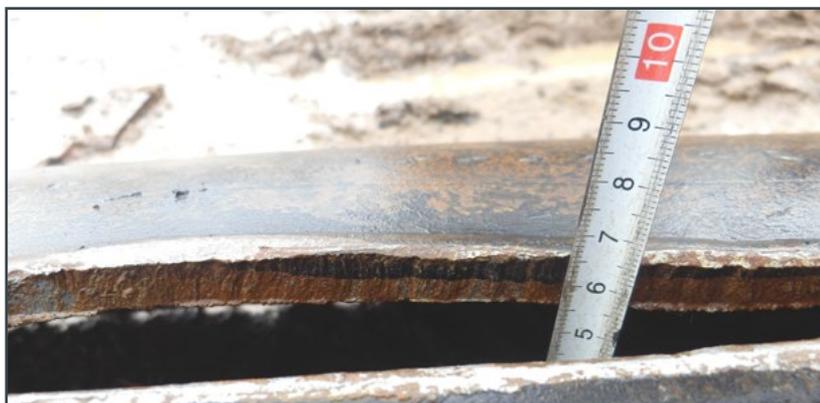
Figure 7: Fracture surface

We found that the pipeline bitumen coating penetrated on the fracture surface up to the depth of 7 mm while the total thickness of the longitudinal weld was about 11 mm (see Figure 7). This area at the outer surface with incoherently black coating was about 150 mm long, but the total length of crack reached a length of up to 250 mm.

The investigation revealed that the coating was a usually used bitumen insulating primer. The primer must have penetrated into the crack at a hot temperature during a coating process. It clearly showed that this longitudinal crack created already in the process of production and has existed in the pipeline for more than 40 years. During the whole period it remained hidden to all available internal inspection methods used in the last 13 years.

One destruction of the testing section occurred during the integrity test. In the course of destruction the pressure in the pipeline decreased to 0 bar during 1 second. It represents a water leakage of about 10 m³. The damaged part of the pipe was cut out and investigated. A longitudinal crack in the middle of the longitudinal weld on the external pipe wall caused the destruction.

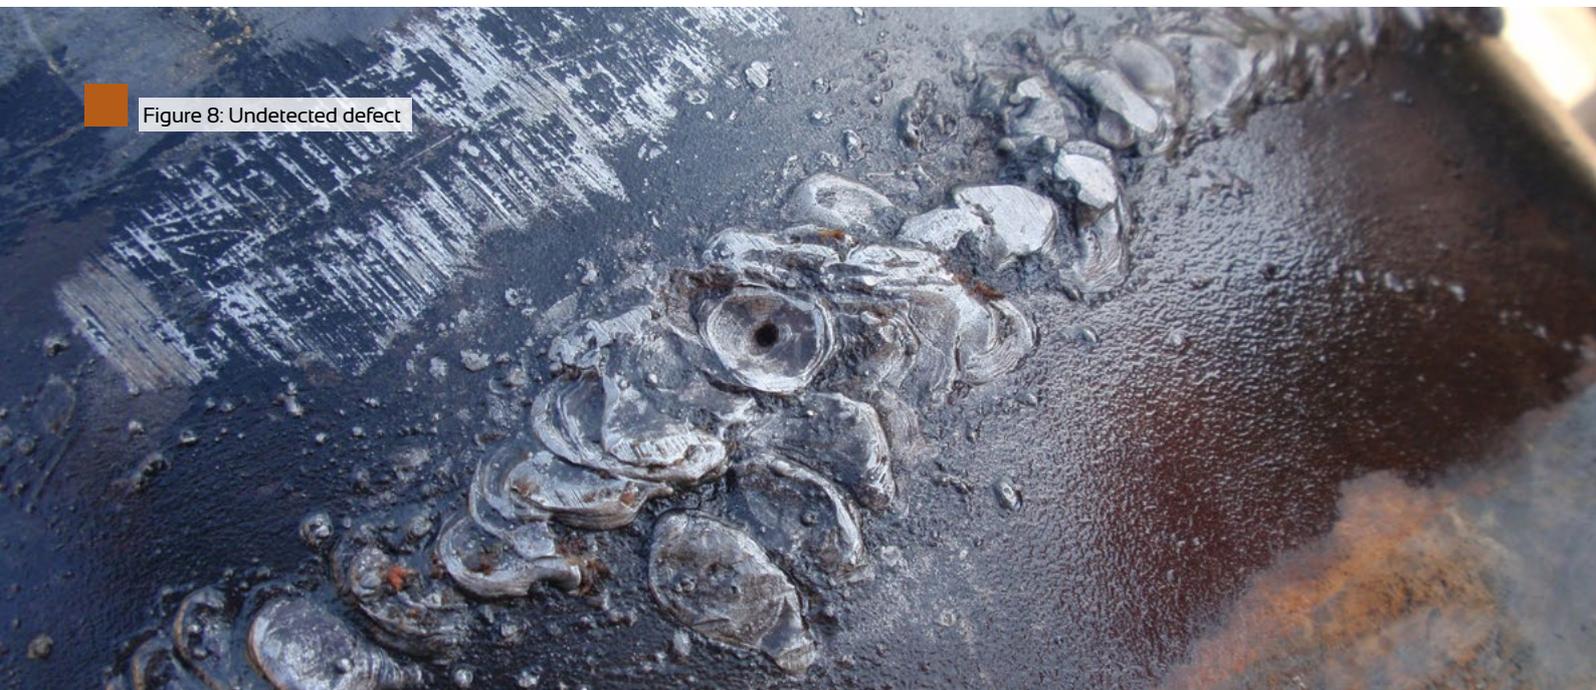
Figure 8: Undetected defect

were detected. These critical defects were not only recommended for repair, but quite often they were not detected by the intelligent tool (For example see Figure 8).
