**Exchange of 32 pipes of crude oil
pipeline DN 500 within 88 hours**

CEPS a.s.

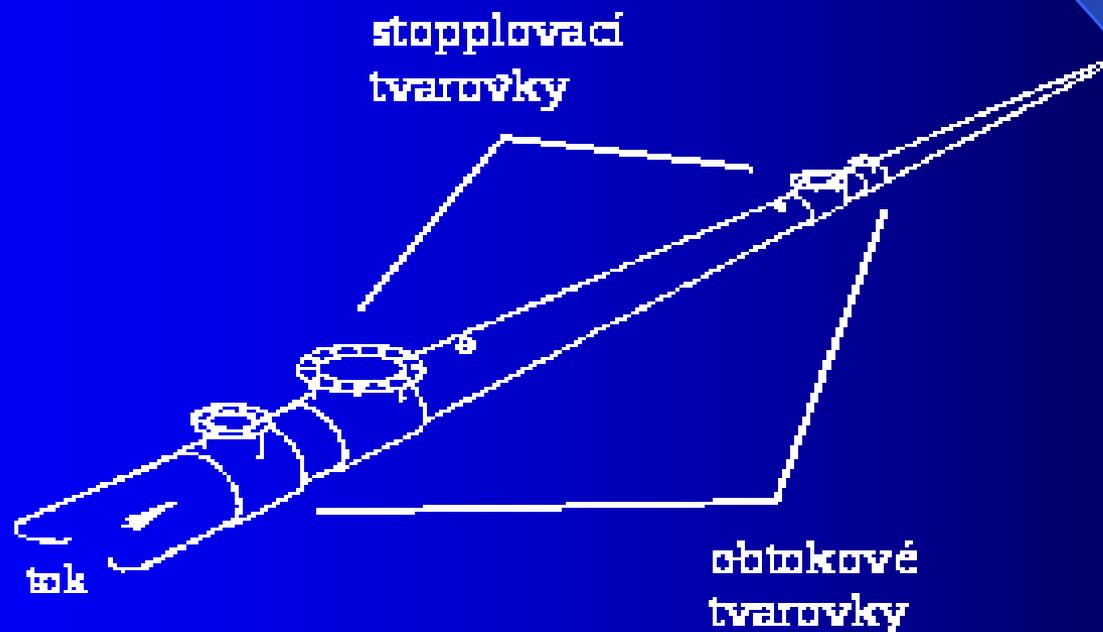
Closing the Line Using T.D.W. Stopple

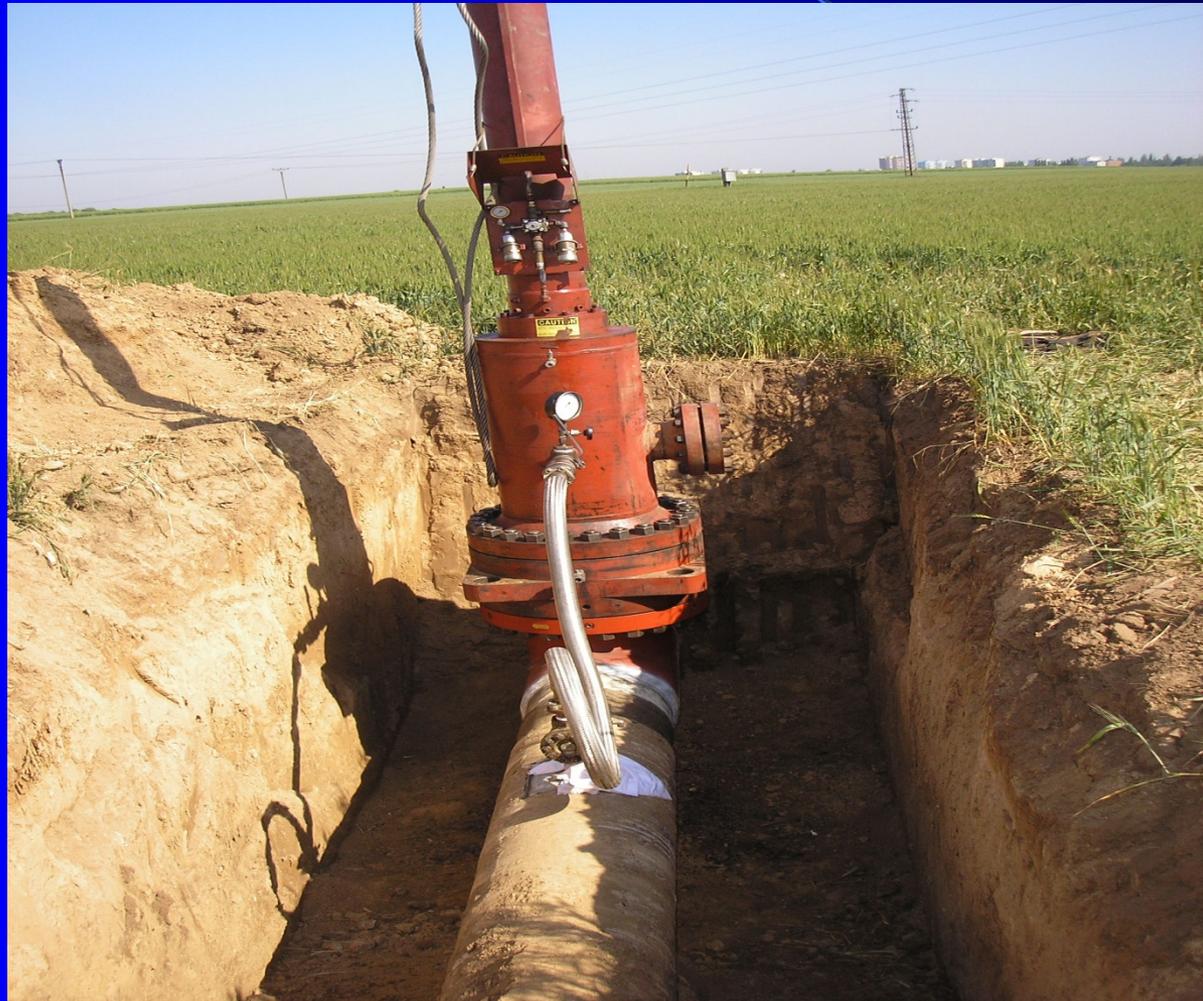
Oil Removing from the Space for Welding

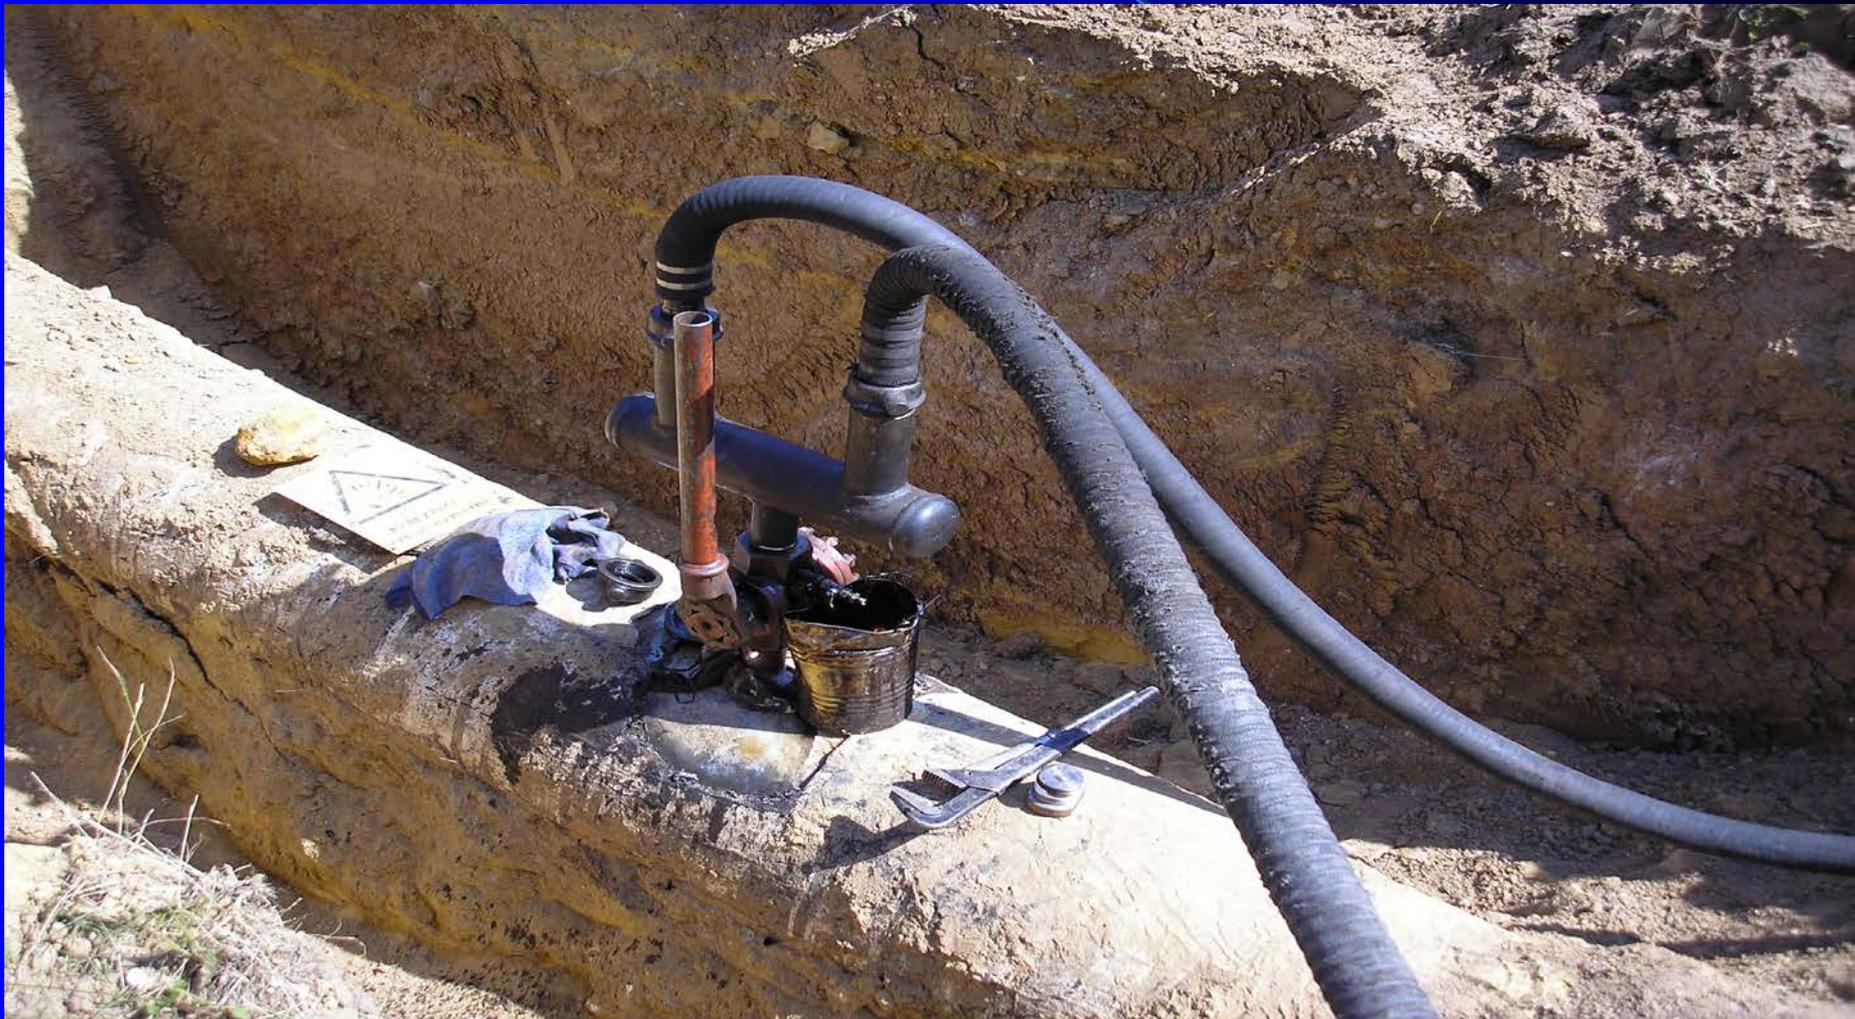
Cutting out the Pipe to be Replaced

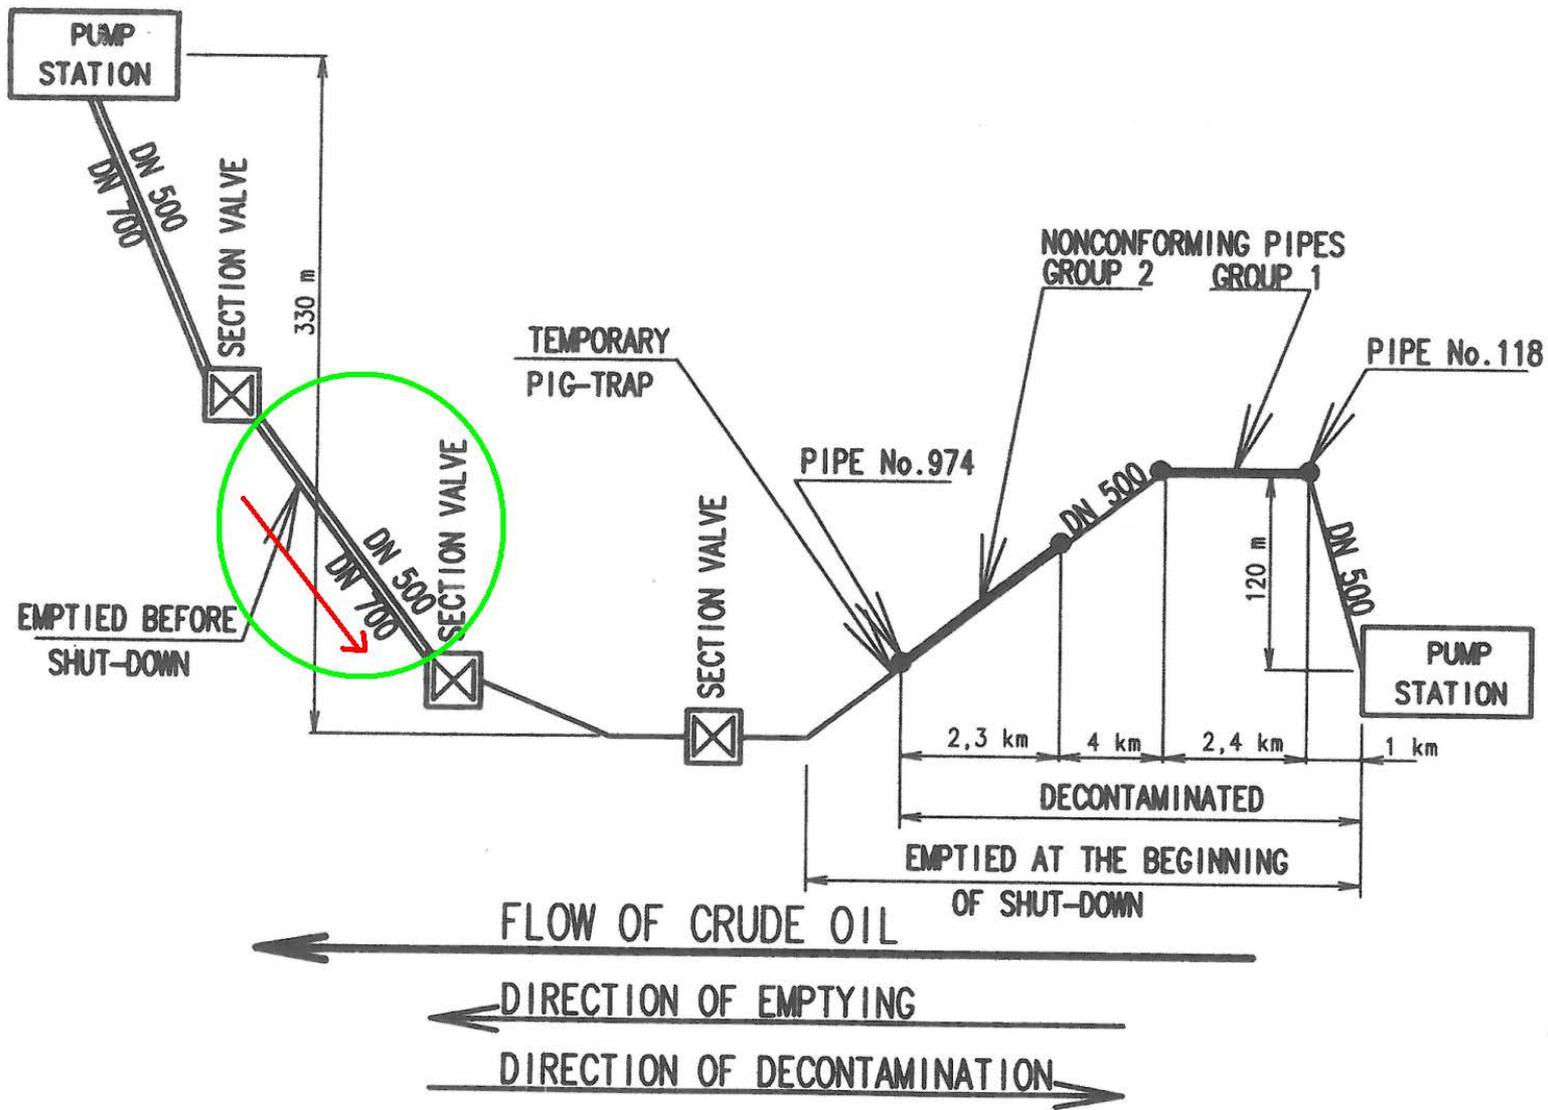
The emptying of a part of DN 700 pipeline was done using the pig pushed downhill in the direction from the upper end of the emptied part, the crude oil was moved to tank trucks at the lower end, than the oil was transported to storage site.

The crude oil was displaced to tank trucks at the lower end, and the oil was transported to storage site.

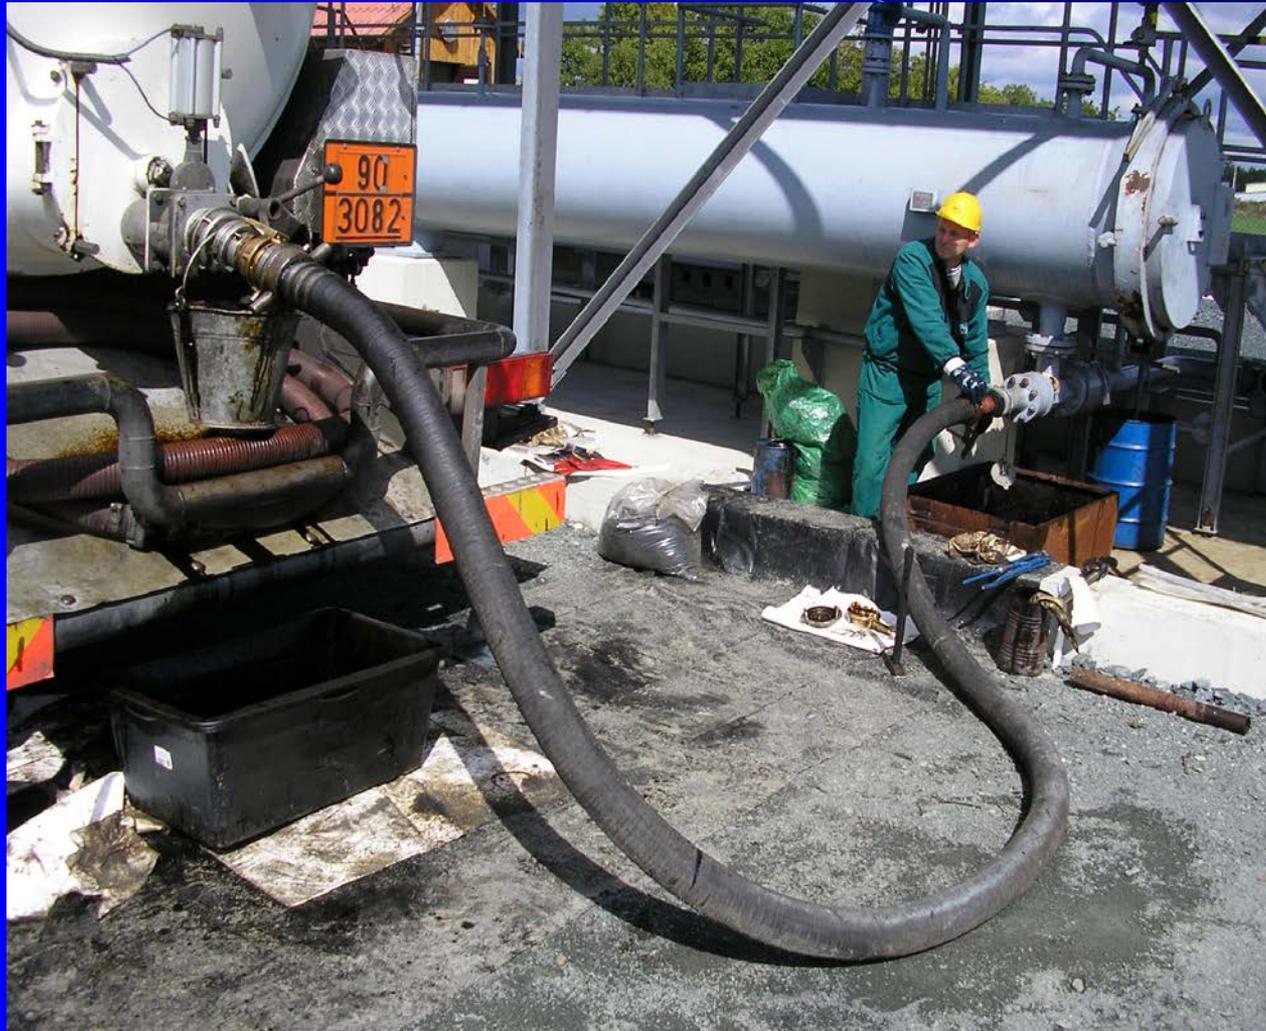
The emptying of a part of DN 700 pipeline took 5 days, when 8 tank trucks performed the job.

Displacement of Crude Oil from DN 700 Pipeline

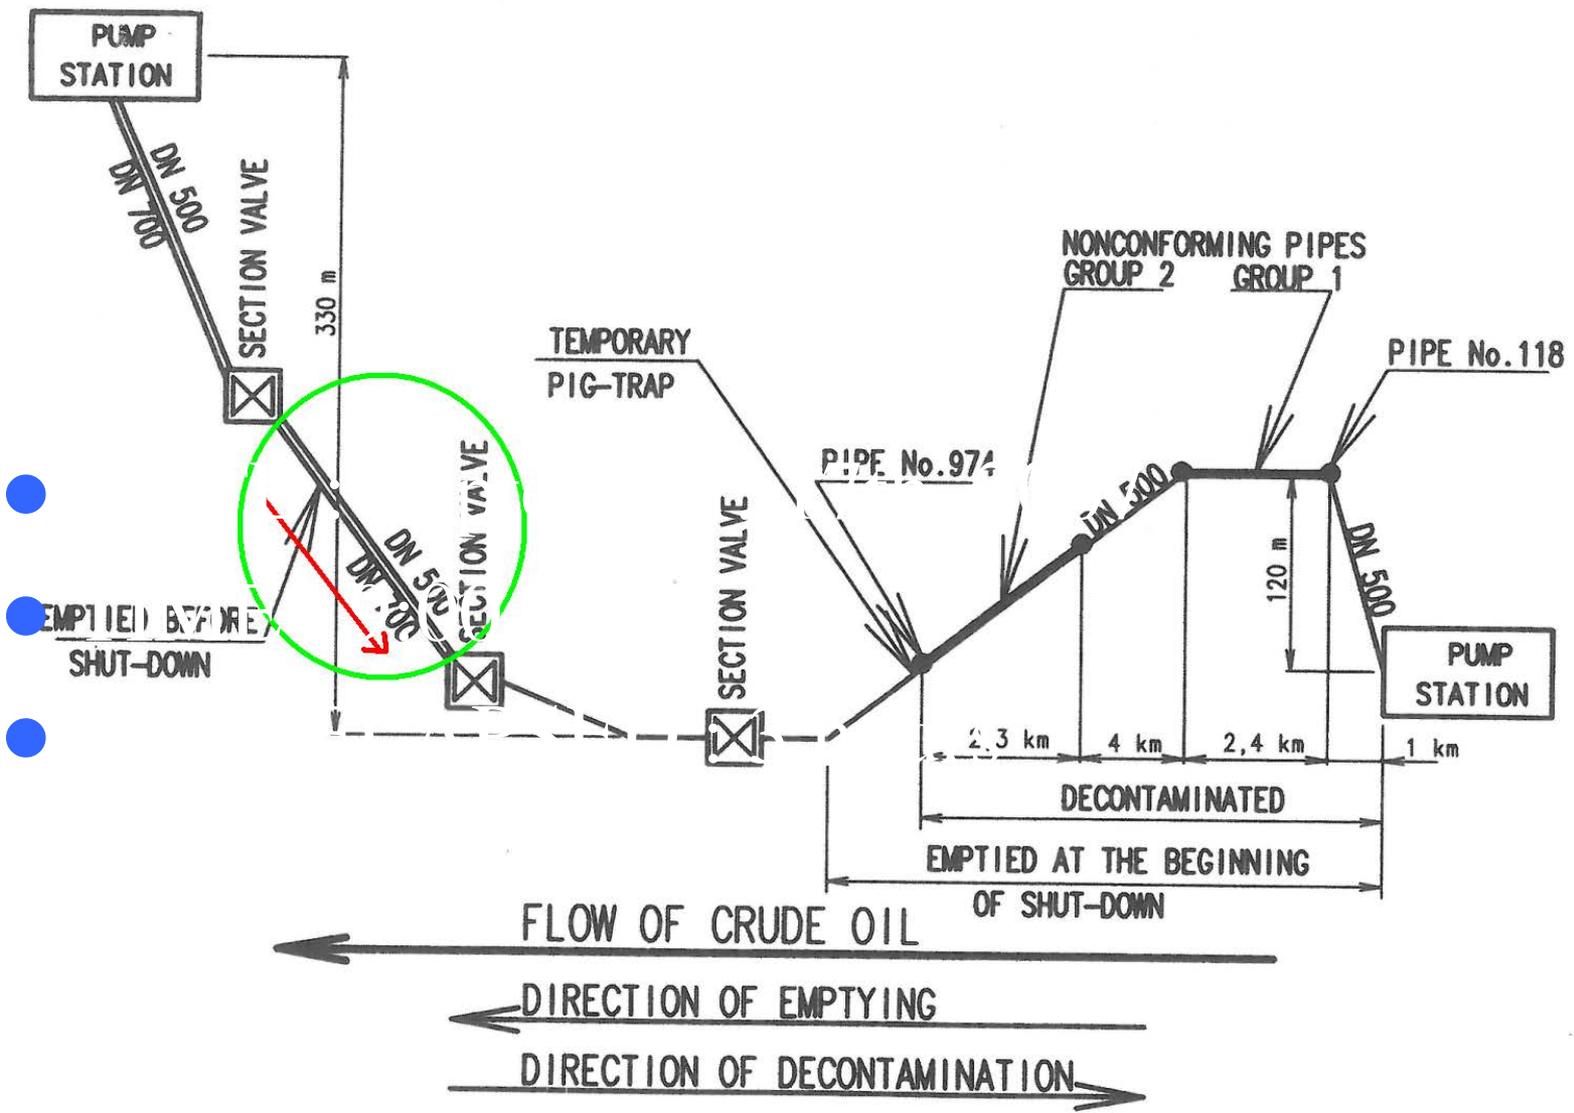
The last downstream pipe (No. 974), which was planned to be replaced, had been cut out using flameless technology. The next downstream pipe (No. 975) is closed by PLP sealing pig.

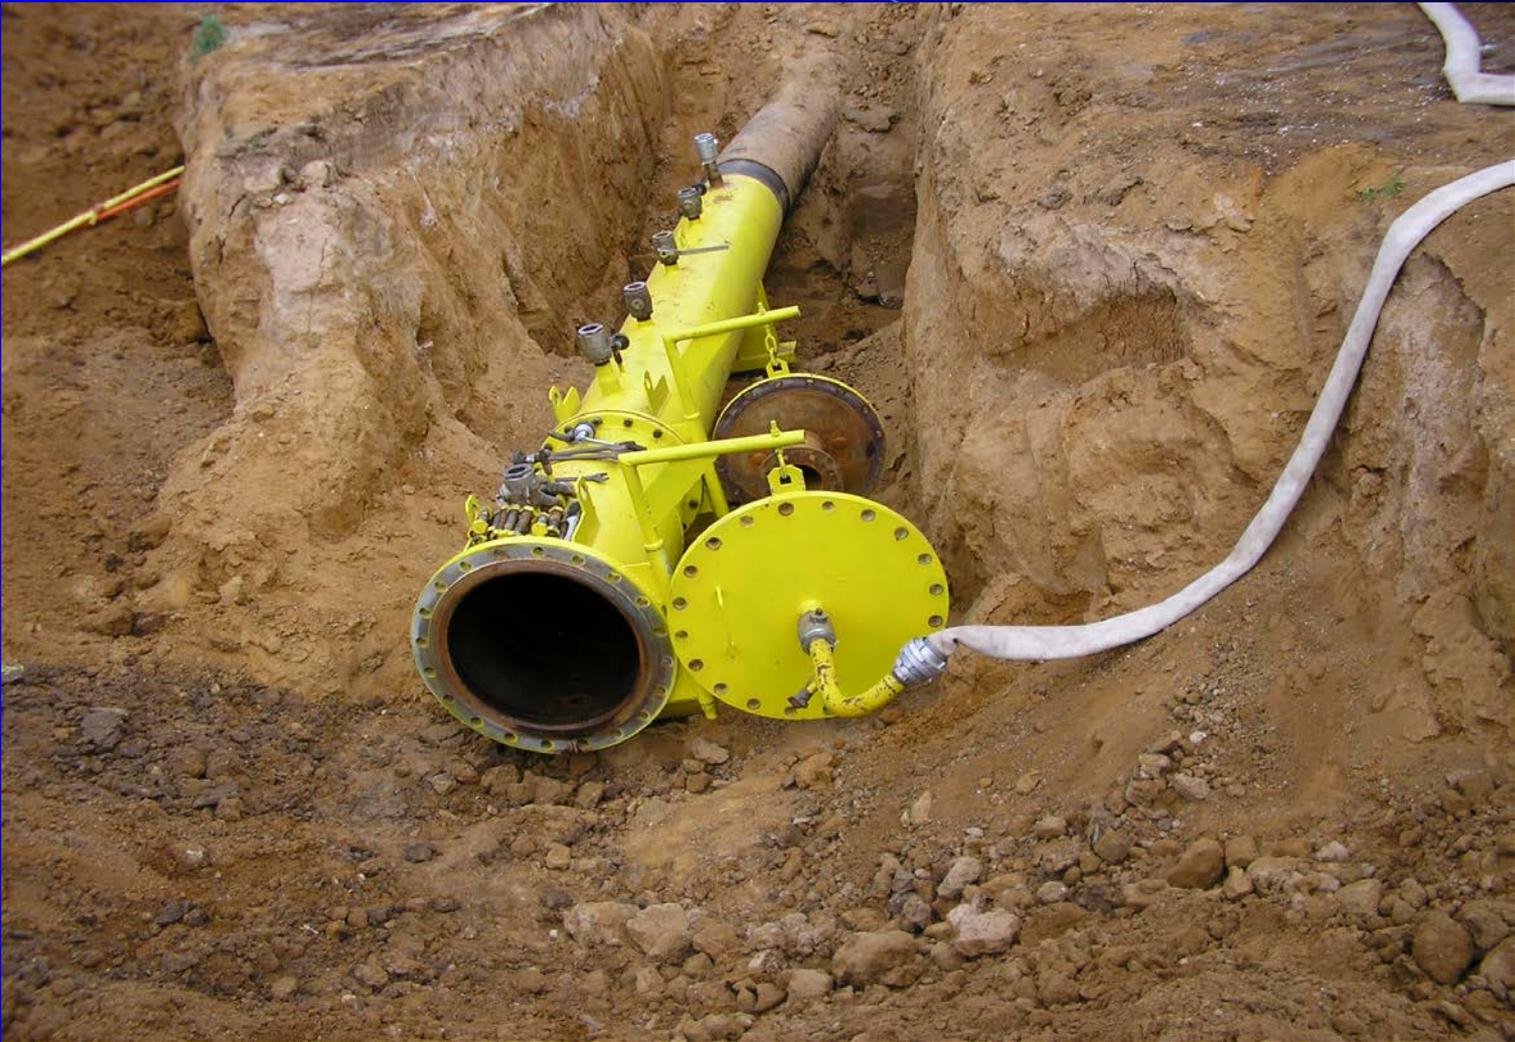
The opened pipeline was temporarily sealed by clay plug. The end of pipe was manually cleaned to ensure safe welding area.

The temporary cleaning pig trap was welded onto the pipeline end.

Pipeline with Temporary Cleaning Pig Trap

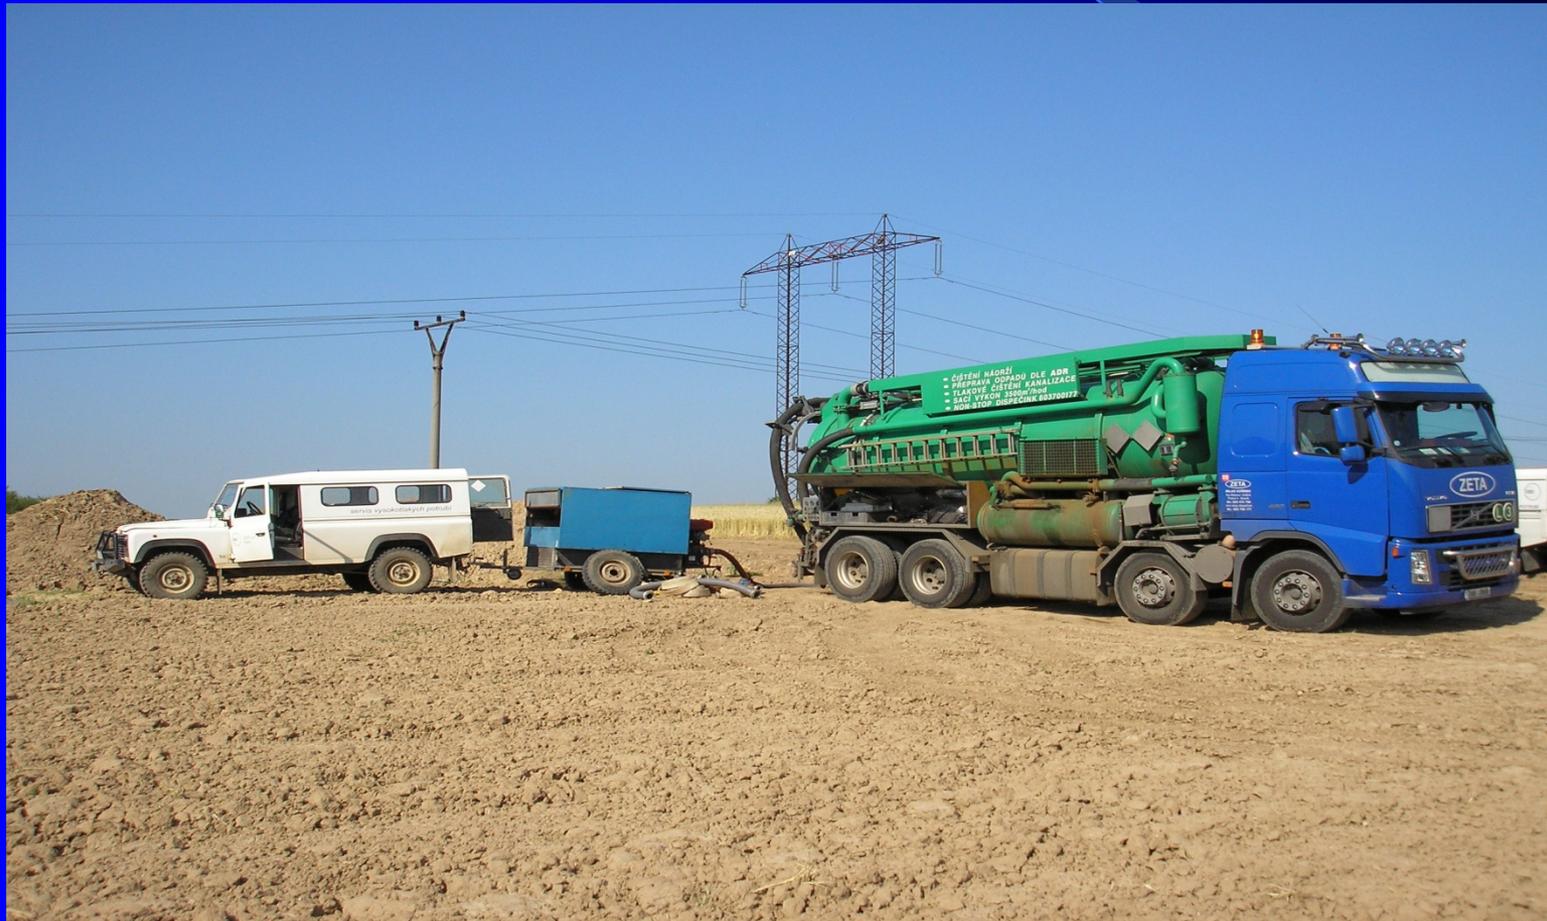
Tank-truck for Transport and Preparing of Cleaning Agent Petrosol Solutions

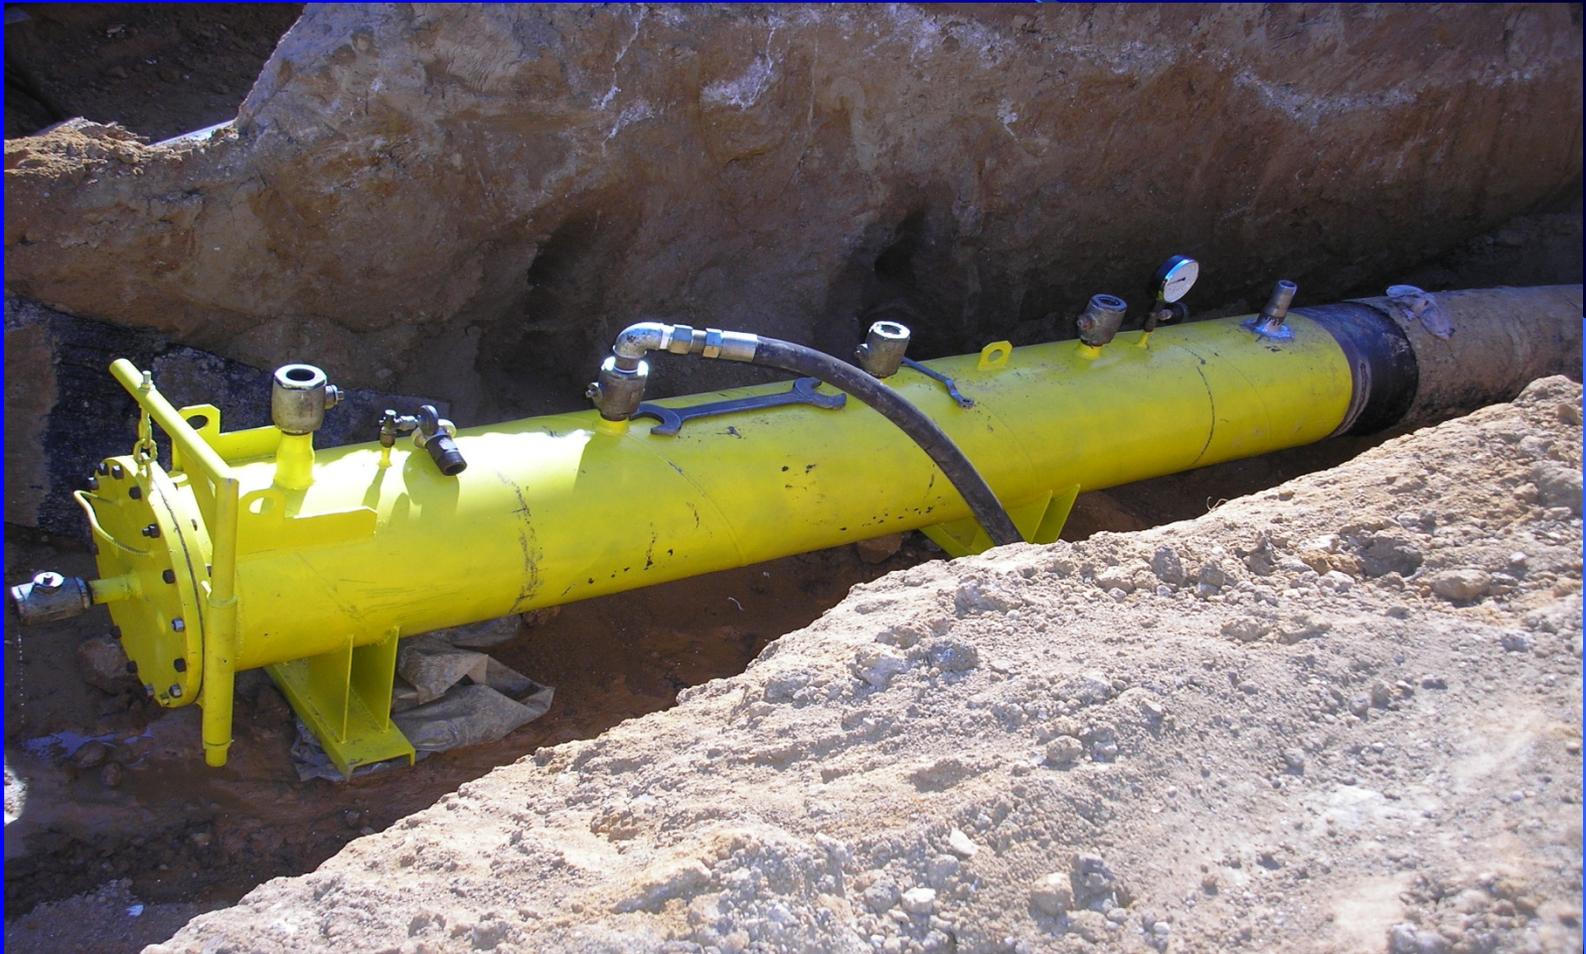
The pig train was moved by compressed air from the end of pipeline part which is repaired, in the opposite direction – towards upstream pumping station, where used solution will be pumped into the tank trucks.

Moving the Pig Train by Compressed Air

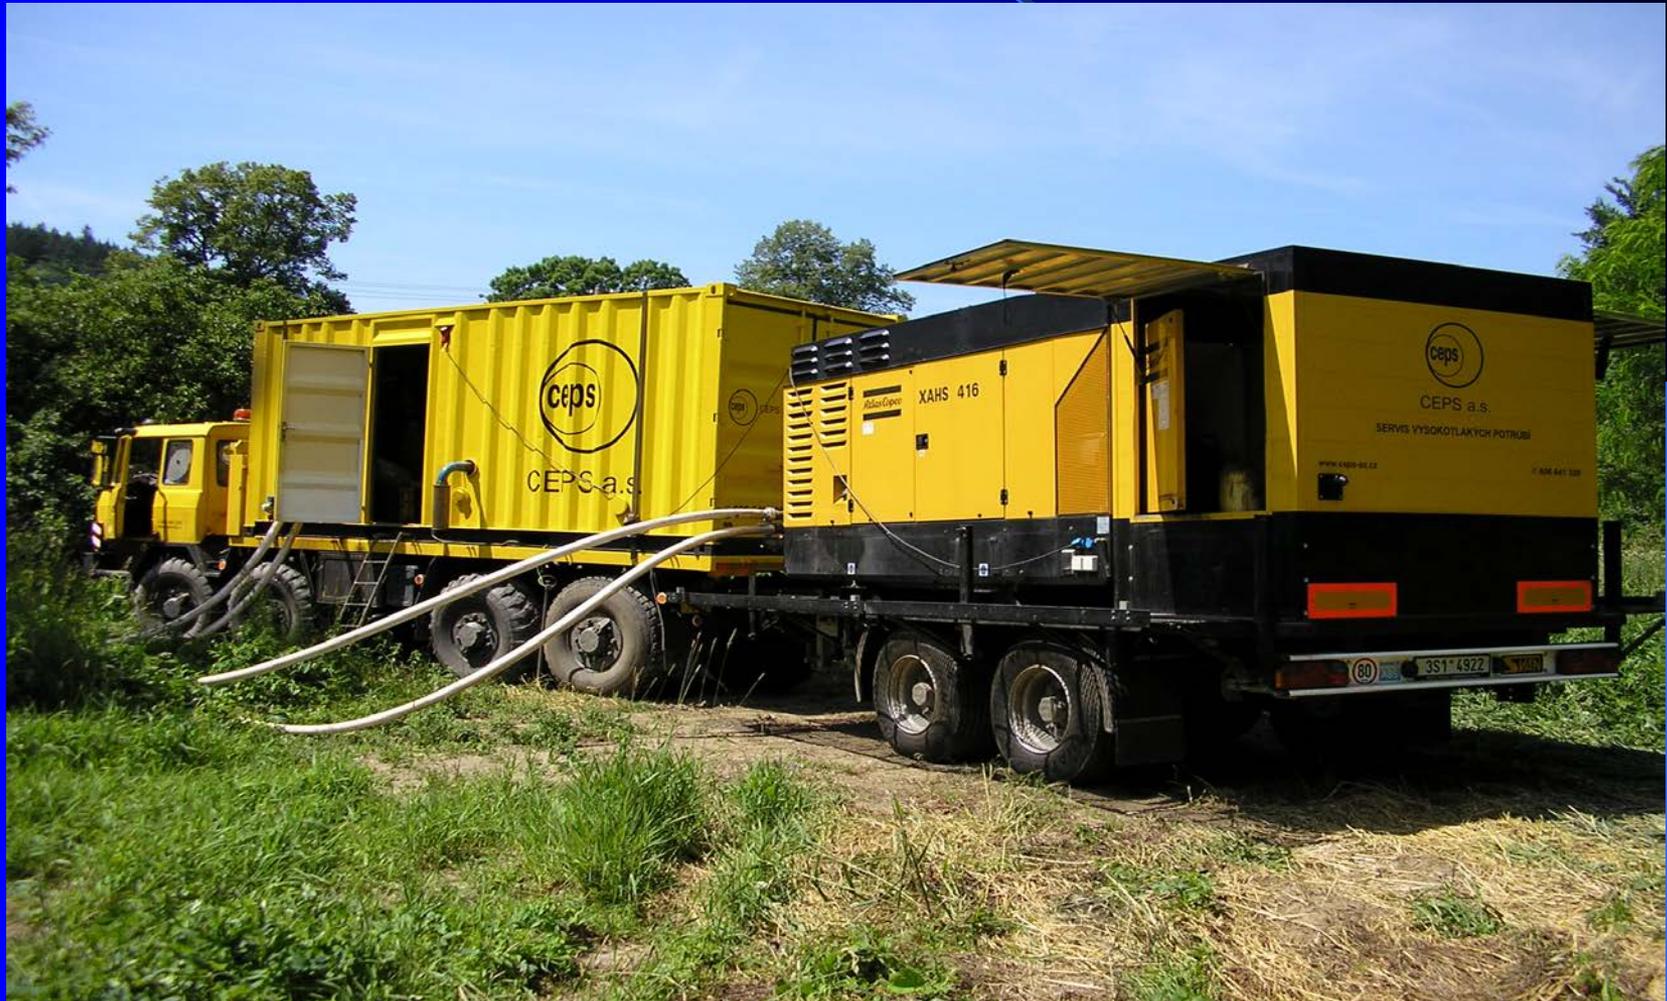
Moving the Pig Train by Compressed Air

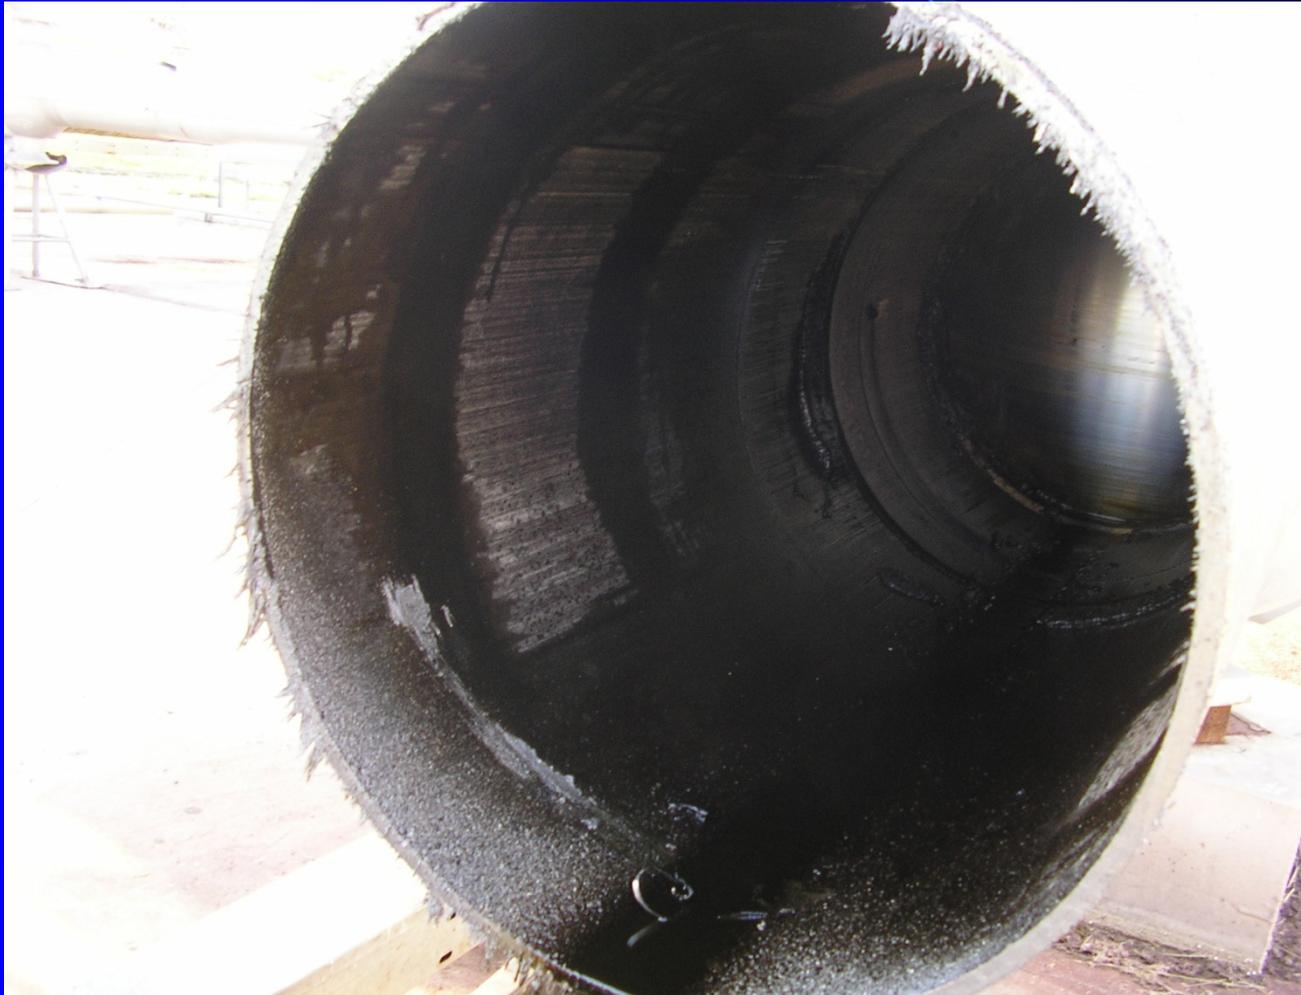
Pipeline before Cleaning – Note the Oil on the Wall

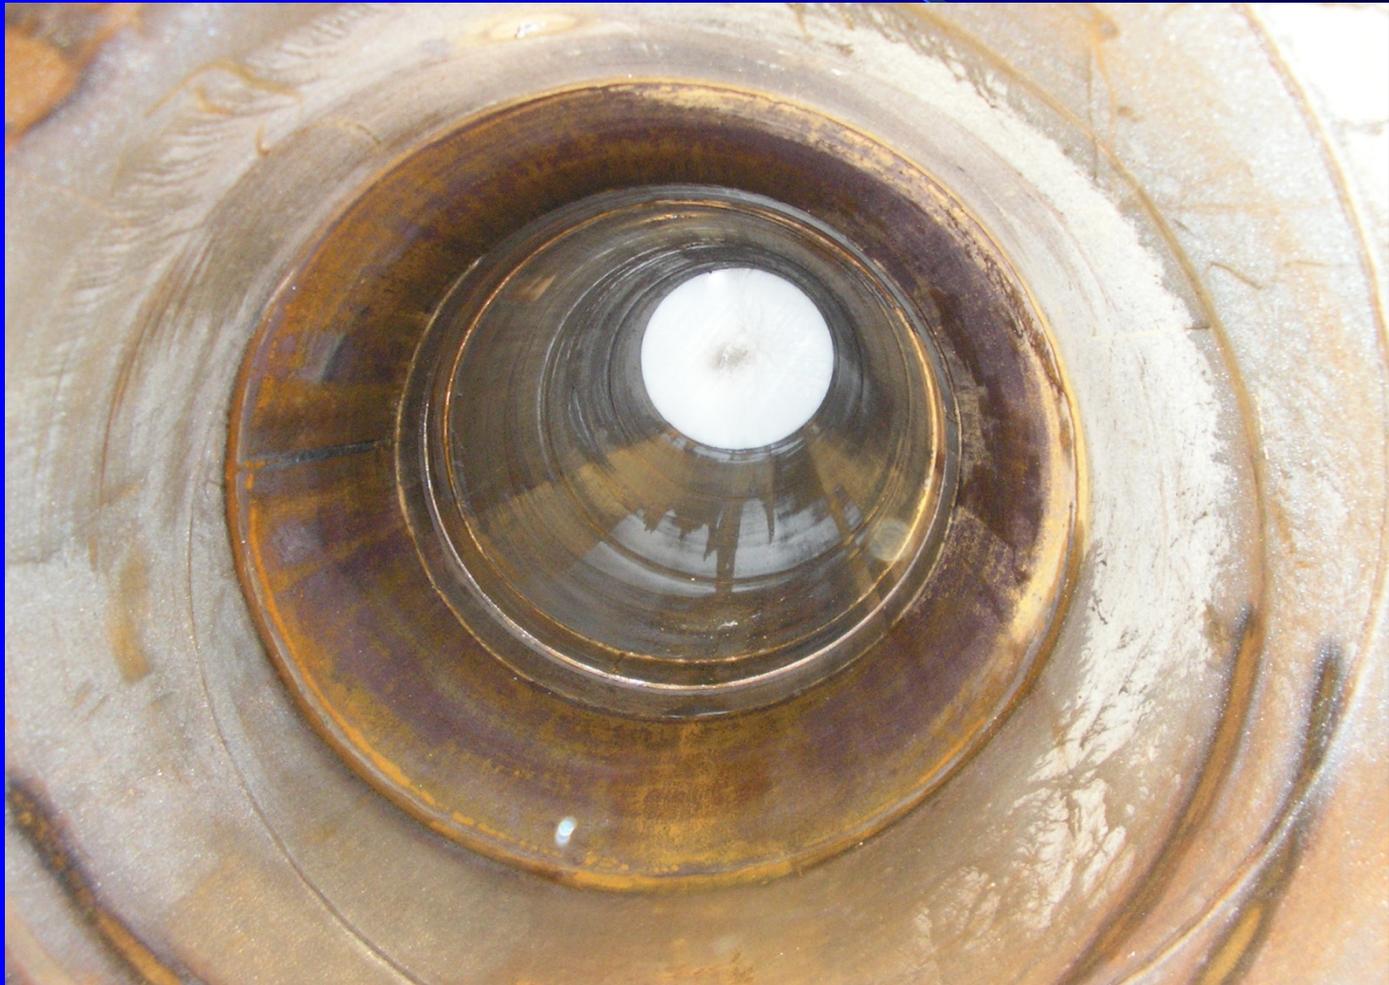
Really Clean Pipeline Prepared for Repair

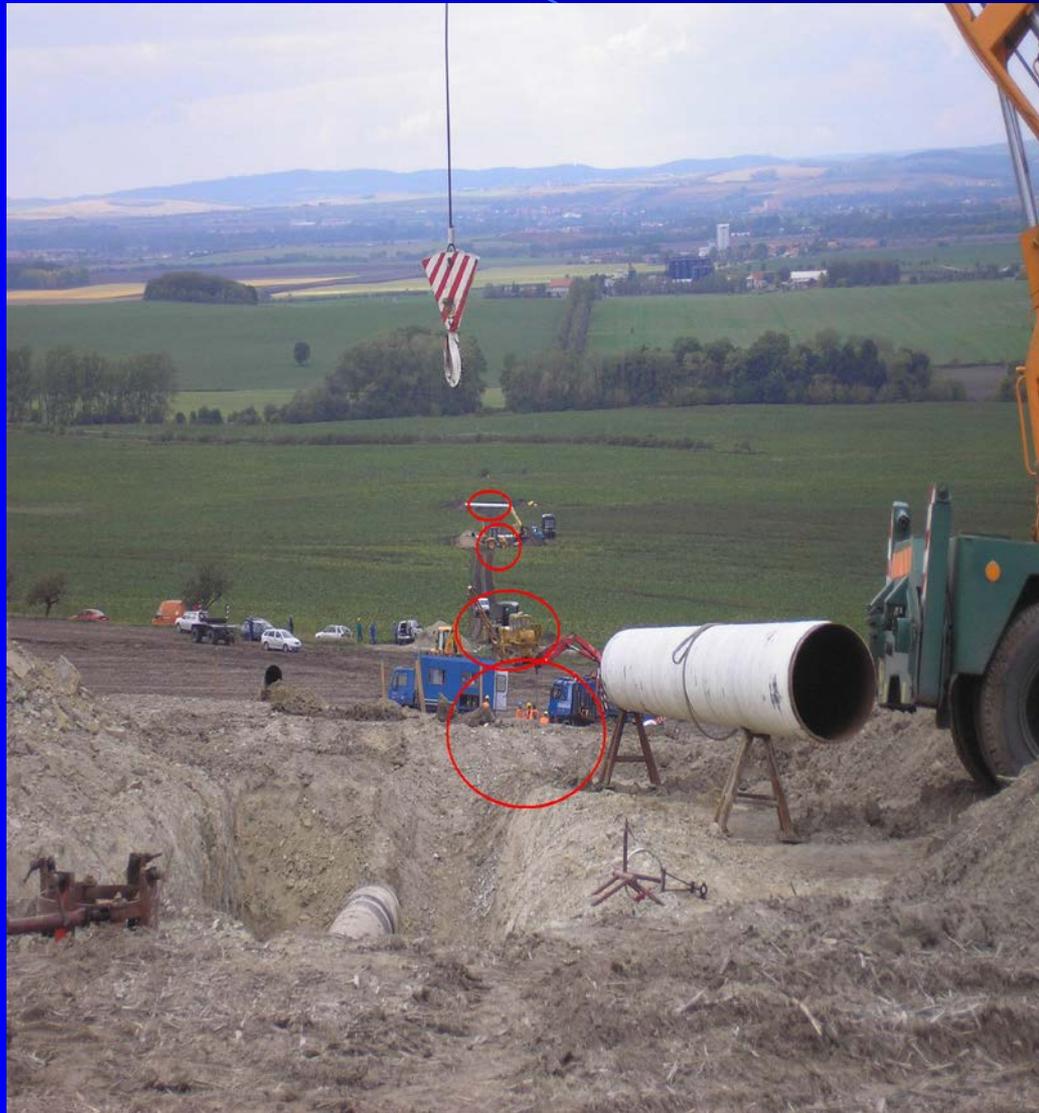
The View of 5 Individual Job Sites

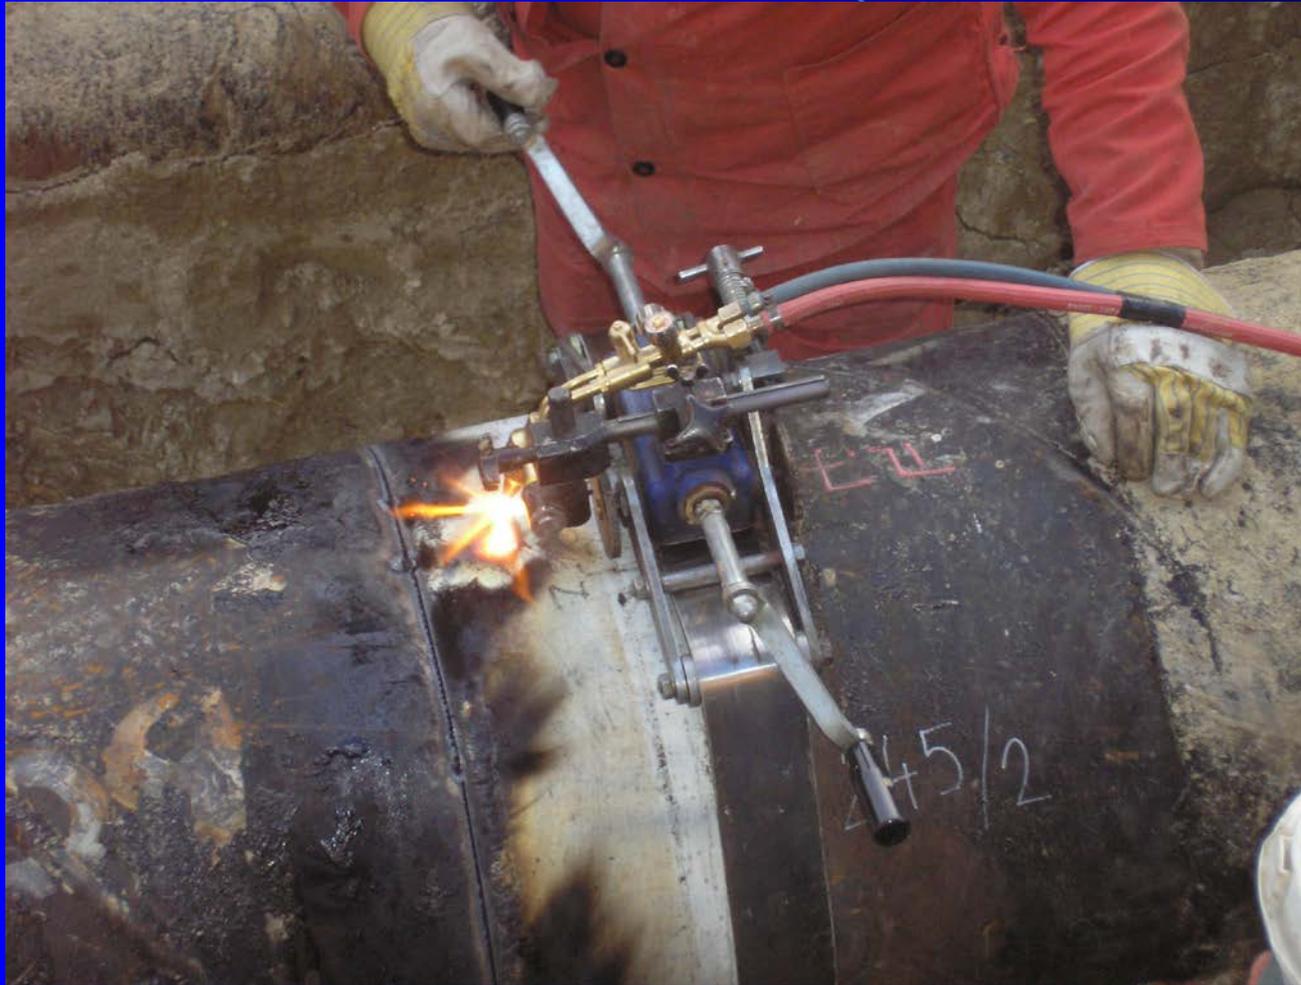
At each individual job site the cut-out was made, the new pipe welded on and NDT performed.

Cut-Out of the Nonconforming Pipe

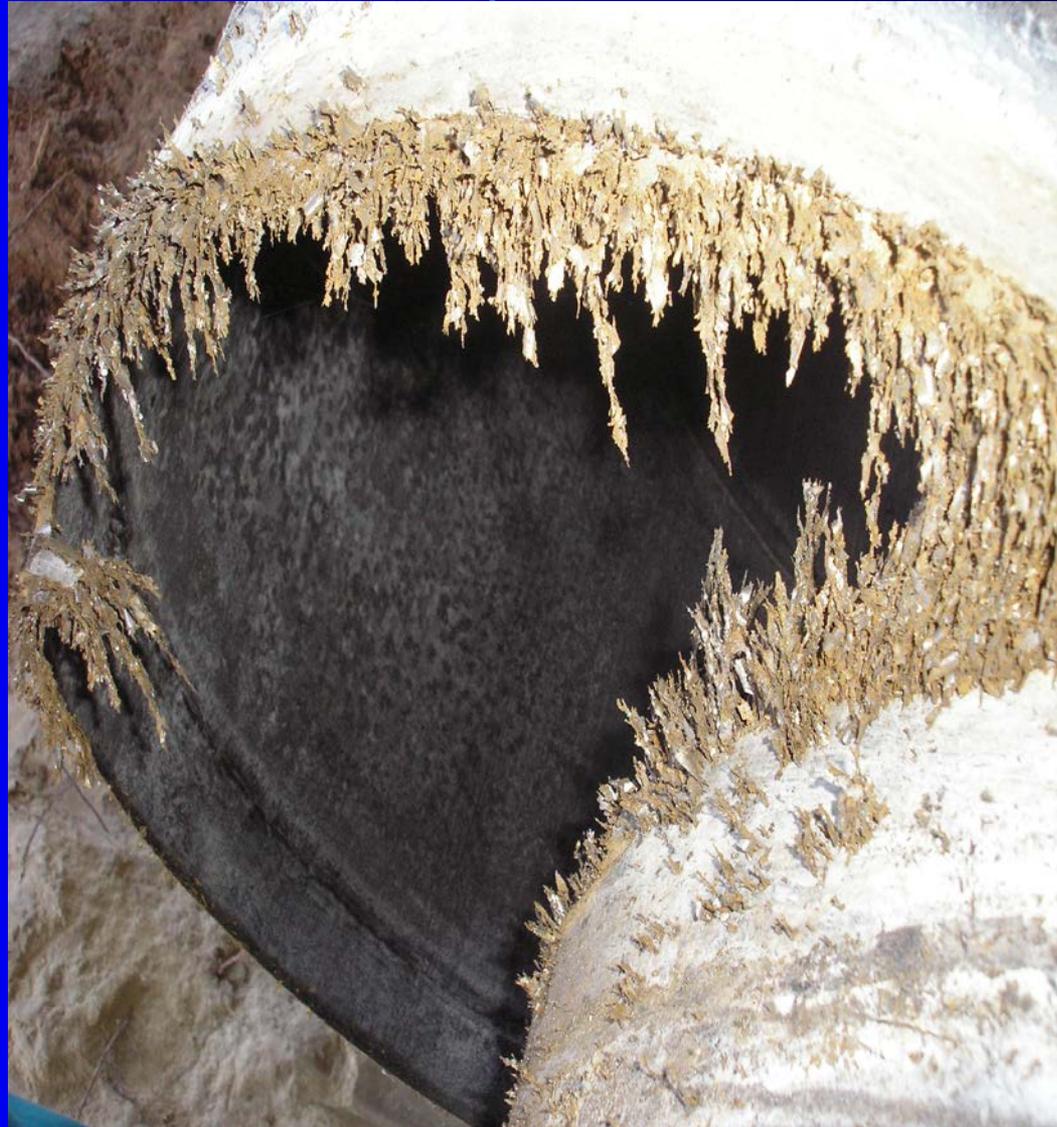
Another problem came - the pipeline wall was intensively magnetized due to the run of MFL on-line tool. The magnetic force was strong enough to catch the hammer.

It was really not good for welding.

Pipeline Wall Magnetization

The residual magnetic field was compensated using the wrapping the pipe by loops of welding cables.

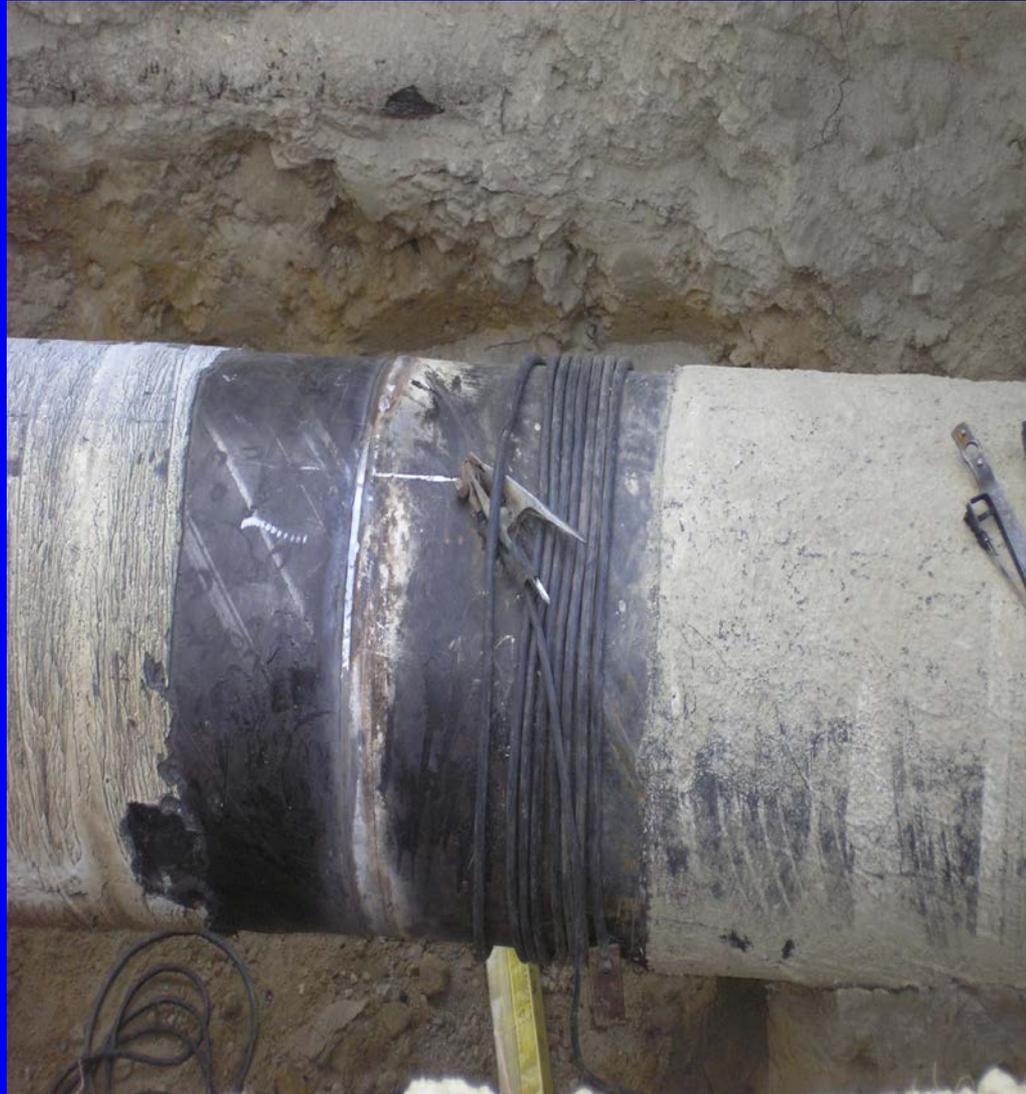
The Compensation of Pipeline Wall Magnetization during the Welding
