**Exchange of 32 pipes of crude oil
pipeline DN 500 within 88 hours**

CEPS a.s.

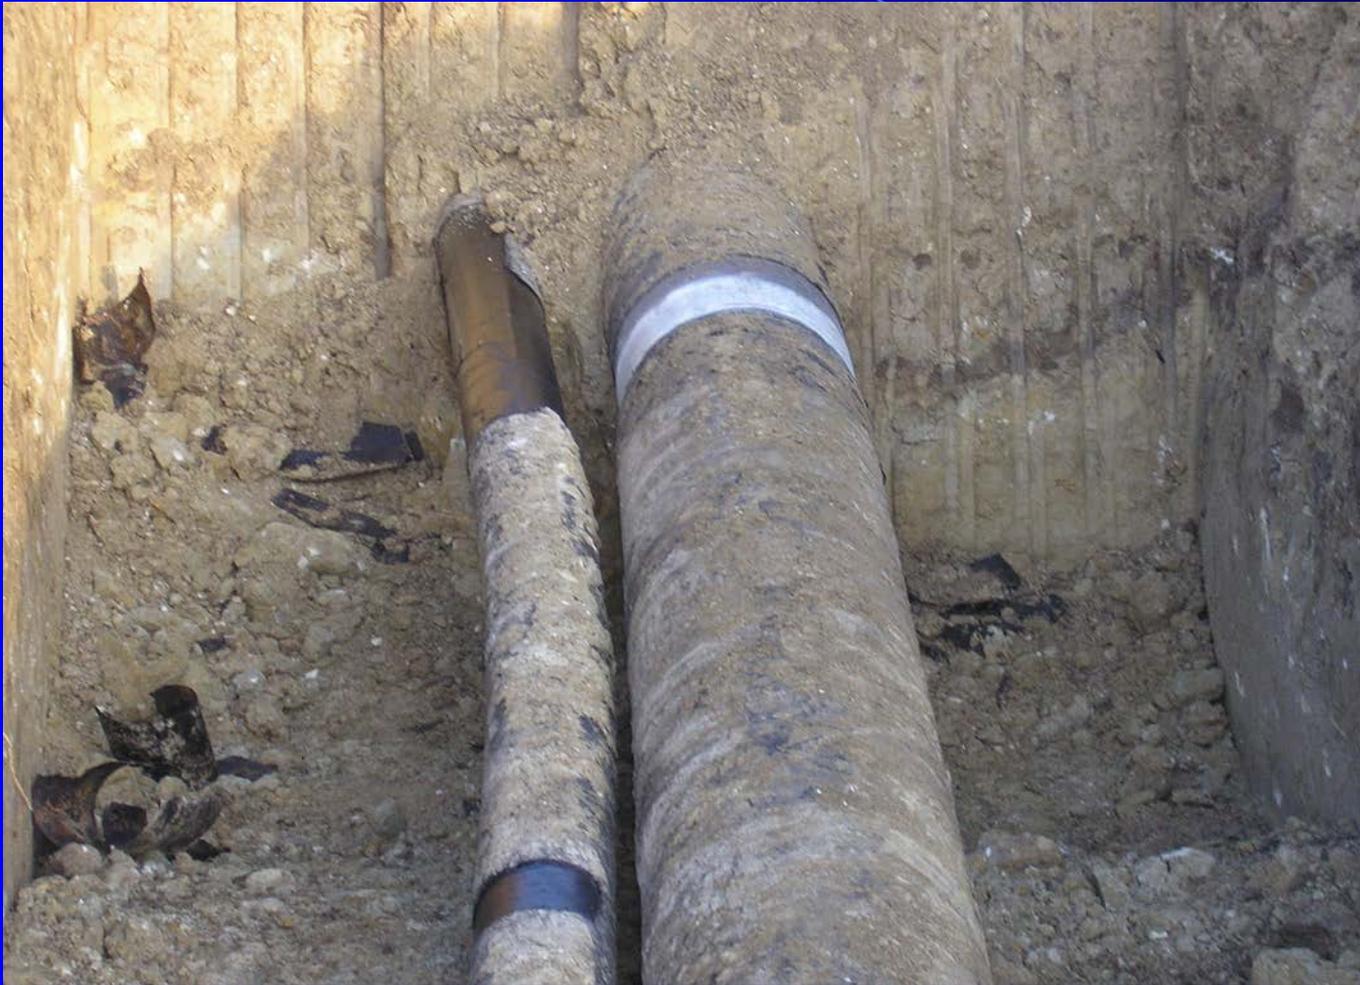
At several places the situation
really was not easy

Position of the Pipeline at Site No. 118
